LOCA TESTING OF HIGH BURNUP PWR FUEL IN
THE HBWR. ADDITIONAL PIE ON THE
CLADDING OF THE SEGMENT 650-5.

Address Telephone Telefax	KJELLER NO-2027 Kjeller, Norway +47 63 80 60 00 +47 63 81 xx xx	HALDEN NO-1751 Halden, Norway +47 69 21 22 00 +47 69 21 22 01	open
Report number IFE/KR/E-2008/004		Date 2008-04-11	
Report title and subtitle LOCA testing of high burnup PWR fuel in the HBWR. Additional PIE on the cladding of the segment 650-5.		Number of pages 35	
Project/Contract no. and name Contract ML080150003		ISSN 0333-2039	
Client/Sponsor Organisation and reference NRC/RES		ISBN 978-82-7017-704-2 (printed) 978-82-7017-705-9 (electronic)	
Abstract <p>IFA-650.5, a test with pre-irradiated fuel in the Halden Project LOCA test series, was conducted on October 23rd, 2006. The fuel rod had been used in a commercial PWR and had a high burnup, 83 MWd/kgU. Experimental arrangements of the fifth test were similar to the preceding LOCA tests. The peak cladding temperature (PCT) level was higher than in the third and fourth tests, 1050 °C. A peak temperature close to the target was achieved and cladding burst occurred at ~750 °C. Within the joint programme framework of the Halden Project PIE wa

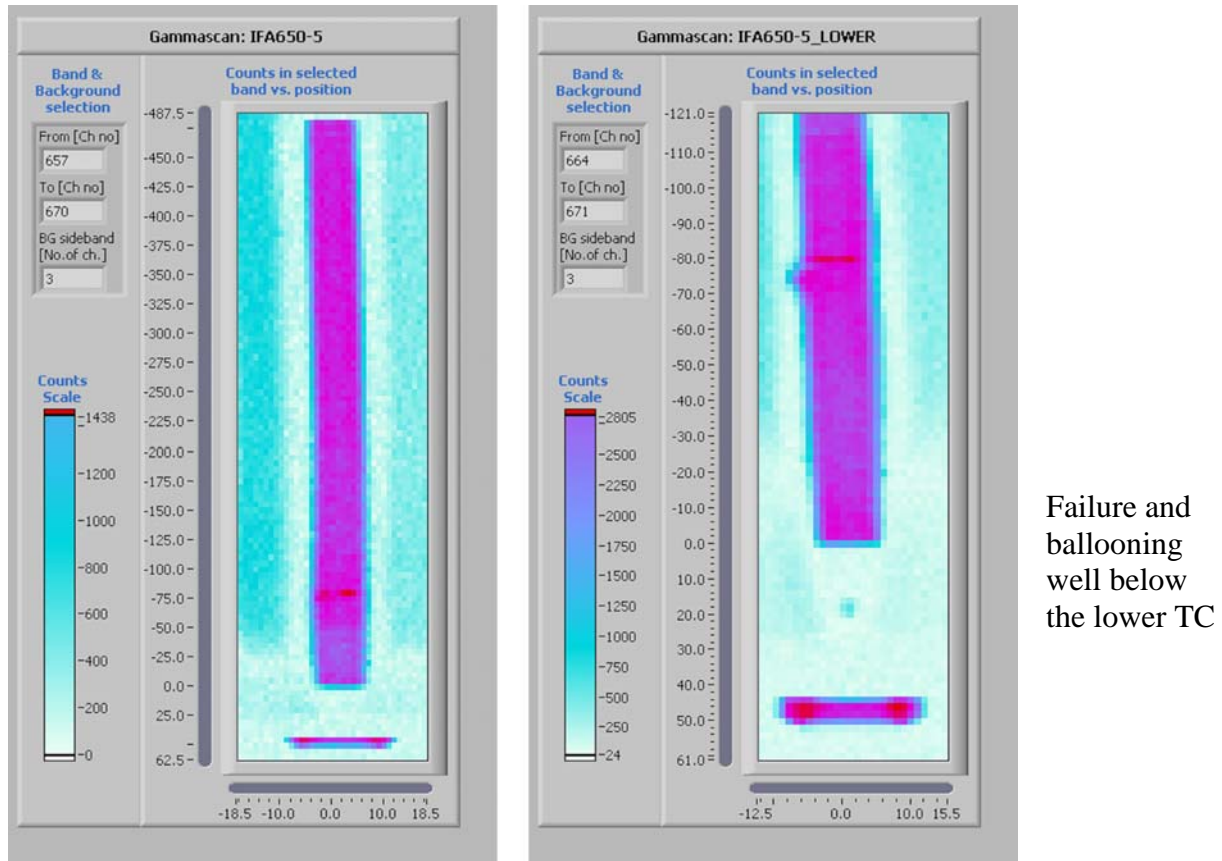
Gamma scanning gave evidence of a failure and cladding distension of the rod segment well below the lower end TC, as documented in Fig. 1. Cladding distension and burst was found 7-8 cm above the lower end active fuel stack.

Fig. 1 Gamma scanning

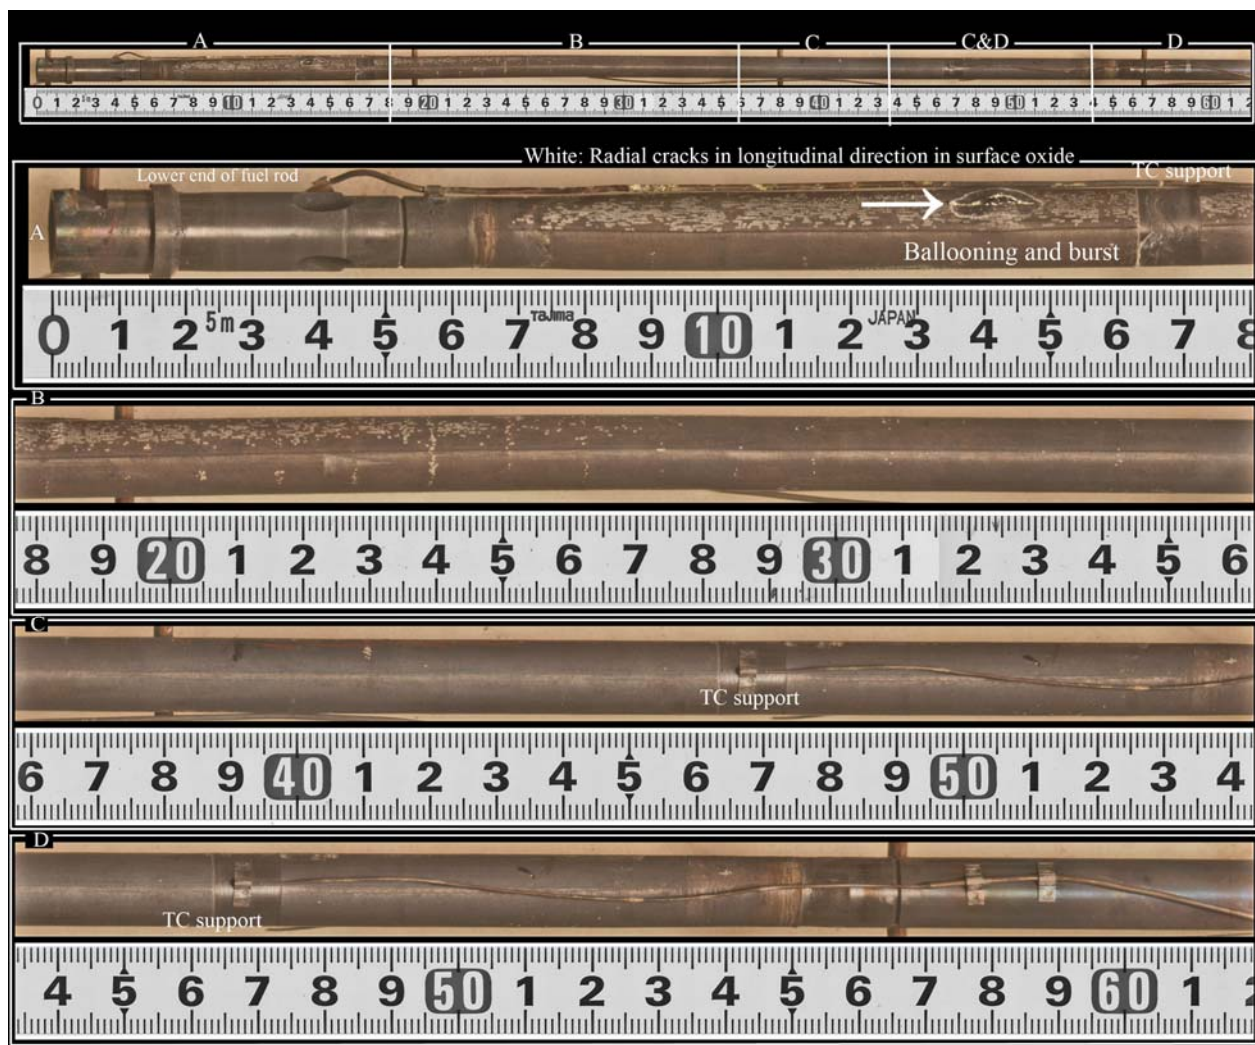
Visual examination was made in two orientations, namely 0° and 90°. As presented in Fig. 2 rod 650-5 showed LOCA induced cladding distension and burst at 7-8 cm above the lower end active fuel stack. The burst is narrow and about 1 cm long. The defect occurred well below the lower cladding thermocouple. The cladding of the high burn-up (83 MWd/kg) PWR rod from which the segment for 650-5 was taken, had an intact, continuous 70-80 micrometer thick oxide on the outer diameter and a hydrogen content of 650 ppm, as reported from pre-test reference PIE. After the LOCA experiment visual examination showed white cracks in the thick outer surface oxide, due to the diameter increase of the cladding. The cracks in the thick surface oxide propagated in longitudinal direction and were visible in the clad oxide between the start of the active fuel stack and up to the axial elevation of about +20 cm. The white oxide cracks, however, were mainly seen in the same angular orientation as the burst, namely around 0°.

Fig.2 Visual inspection

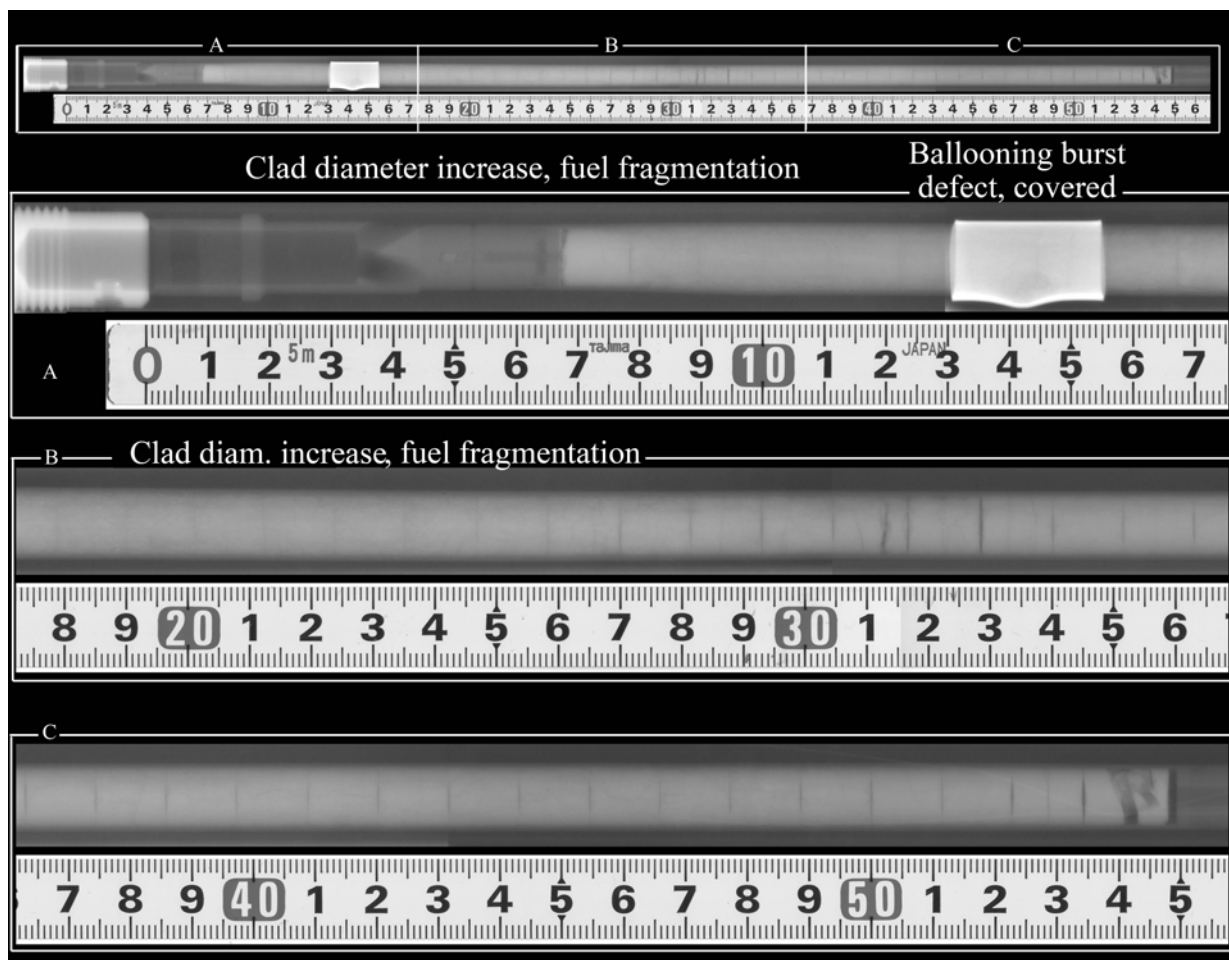
Due to safety reasons the zone with ballooning and burst had to be covered prior to *neutronradiography*. The neutronradiographs showed creep of the cladding diameter in axial direction between the elevation of the start of active fuel stack and axial elevation +22 cm measured from the lower end. In the clad creep range no pellet-pellet interfaces are seen on the neutron-radiographs, see Fig. 3. The neutronradiographs gave evidence of fuel fragmentation and fragmentation in this zone. Above the axial elevation of +22 cm and all way towards the upper end of the active fuel stack the neutronradiographs showed whole pellets and clear pellet-pellet interfaces.

Sampling locations for destructive PIE were at 95mm, 120mm, 150mm, 184mm, 230mm, 470mm, and 517mm measured from the lower end of the rod.

Fig. 3 Neutronradiography

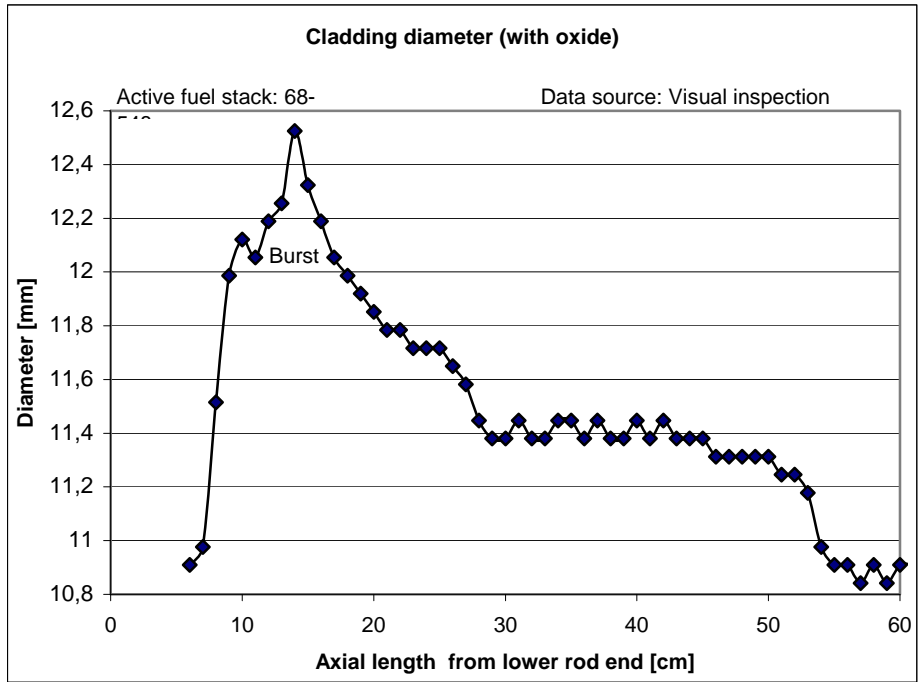
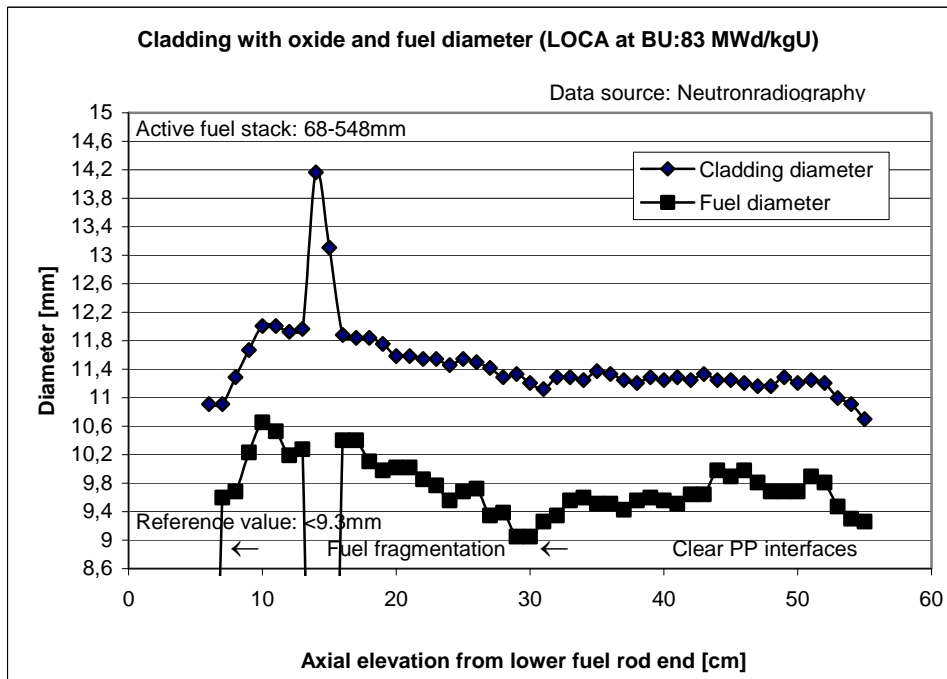
Diameter measurements, based on the visual inspection and neutronradiography were made to estimate the LOCA induced fuel diameter increase and the cladding distension. The results from the NDT observations and measurements were summarized in Fig. 4. Non-destructive PIE showed asymmetric cladding diameter increase with respect to the total axial length of the rod. In the lower end of the rod the cladding diameter increased steeply and rapidly to its maximum and burst. Burst of the cladding occurred without dramatic cladding distension / plastic deformation of the rod. In the balloon and burst zone the LOCA induced rod diameter increased from 10.8mm to 11.5mm in the upper and to 12.5mm in the lower part of the rod. Compared to the cladding in 650-4 the cladding of 650-5 showed a rather stiff and brittle behaviour. However, the low ductility was as expected due to the high burnup and high hydrogen content of the 650-5 cladding.

The axial fuel diameter variations assessed from neutronradiographs showed in the area with fuel fragmentation a diameter increase from 9.8 to 10.5mm below the clad burst, from there, the fuel diameter slope decreases slowly in the zone with fuel fragmentation to about 9.2mm in the middle

of the active fuel stack. From there and to the end of the active fuel stack the pellet-pellet interfaces were seen clearly in the neutronradiographs and the fuel diameter varied between 9.5 and 10.0mm.

Fig.4. Diameter and cladding distension data are based on NDT-PIE. The LOCA induced cladding defect/burst is in the lower part of the rod and well below the lower cladding TC.

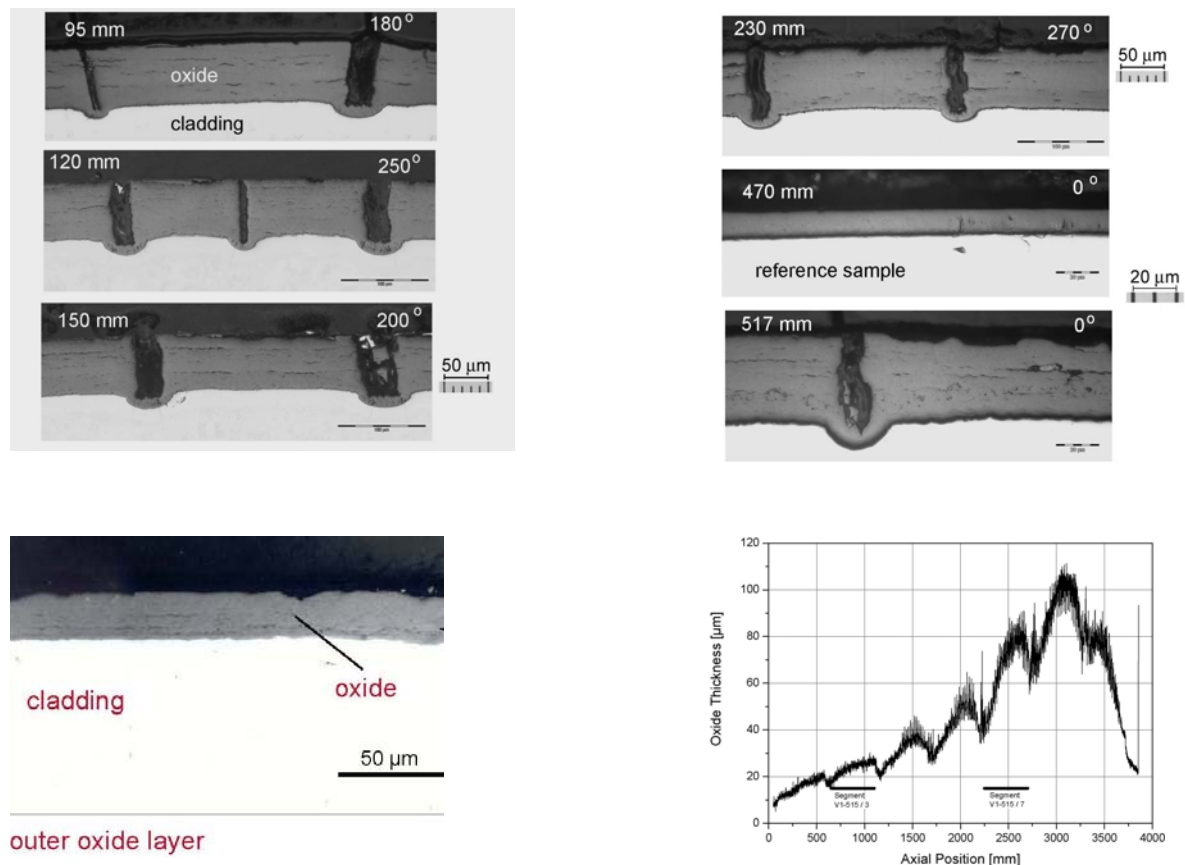
Oxide layer on cladding outer diameter. The pre-test reference PIE suggested an oxide thickness of the rod prior to segmenting and refabrication of 70-80 micrometers. Fig. 5a and b gives PIE details on the cladding oxide after the LOCA test. The measured thickness of the continuous oxide on the outer surface of the cladding (OD oxide) was about 70 μm , whereof the LOCA induced oxide growth was about 11 μm as measured in the TC support (470 mm) location. Here, the oxide was ground off prior to the LOCA test. Other locations showing the LOCA induced oxide growth were found below radial oxide cracks, as shown in Fig. 5a. The lower oxide thickness found in this PIE compared to the reference PIE data can be explained by the different measuring locations on the original fuel rod.

Fig. 5a Oxide layer morphology. The continuous oxide layer on the cladding OD showed radial cracks and a LOCA induced oxide growth below the radial cracks of about 11 μm (upper row). Pre-test reference PIE (lower row).

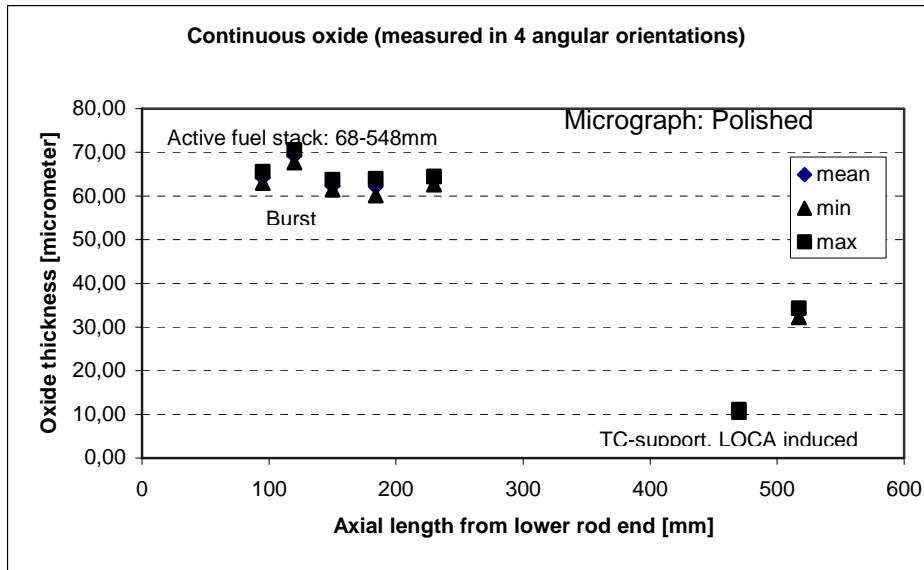
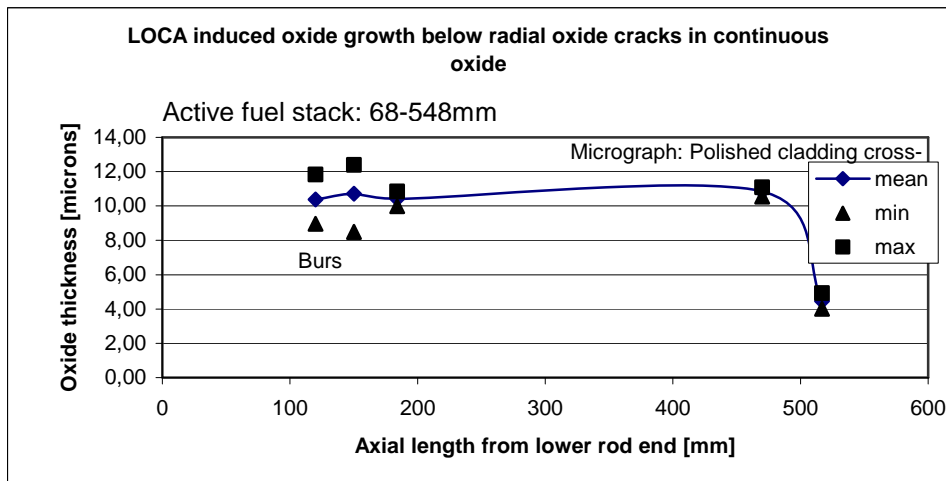
Fig. 5b Measured data for the continuous oxide and the LOCA induced oxide growth (11 μm)

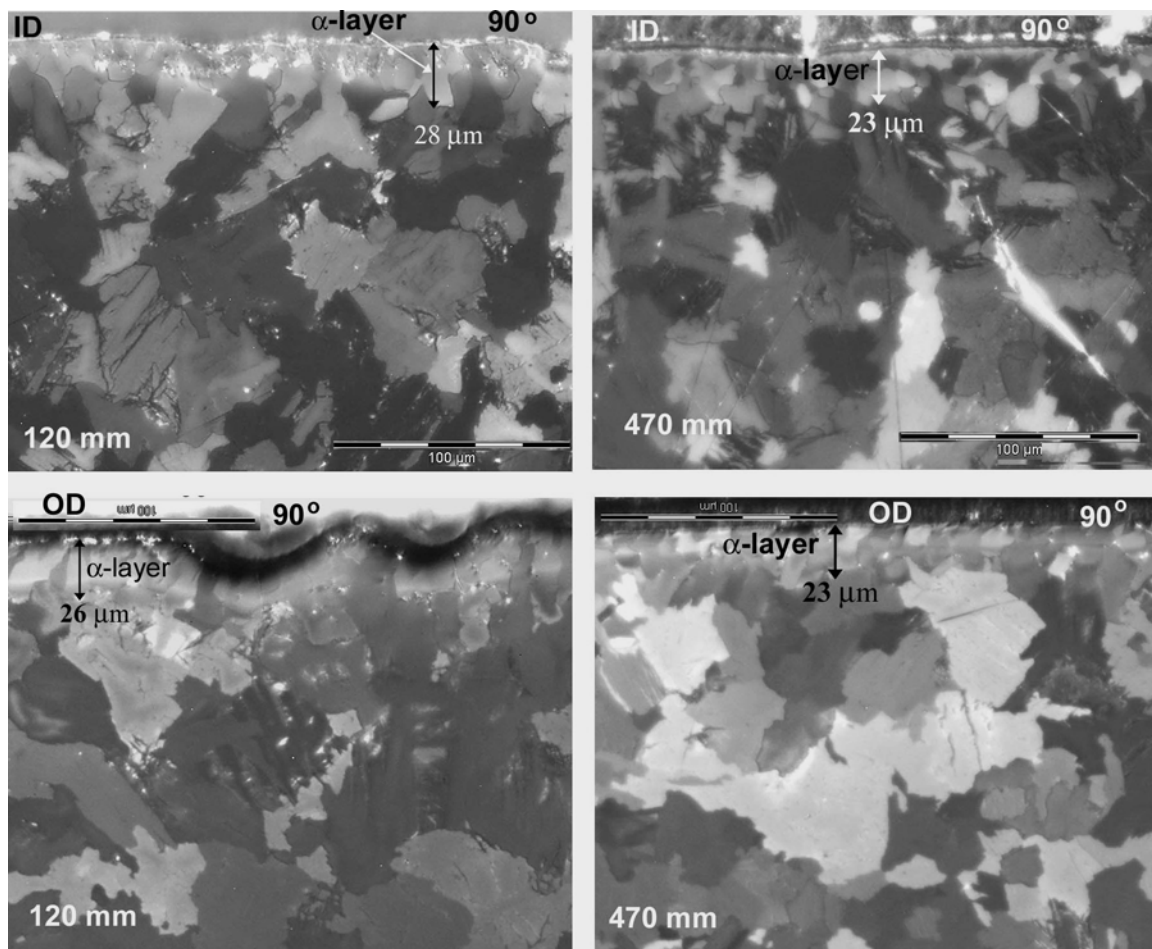
Grain morphology of the cladding. The effect of the LOCA test induced heat treatment on the cladding microstructure e.g. cladding grain size and grain morphology was studied in optical microscopy and polarised light. Metallography revealed as expected and as a result of the temperature excursion above the alpha/beta phase transition temperature a grain growth with former β grains and a Widmanstätten structure. Typically, the grain-size was in the range of 40 μm . Further, the cladding had an alpha layer with smaller grains at the outer (OD) and inner (ID) cladding diameter. The results of the cladding microstructure study in are documented in Fig. 6 a and b.

Fig. 6a The grain morphology study revealed grain growth with Widmanstätten structure and an OD and ID alpha layer with smaller grains.

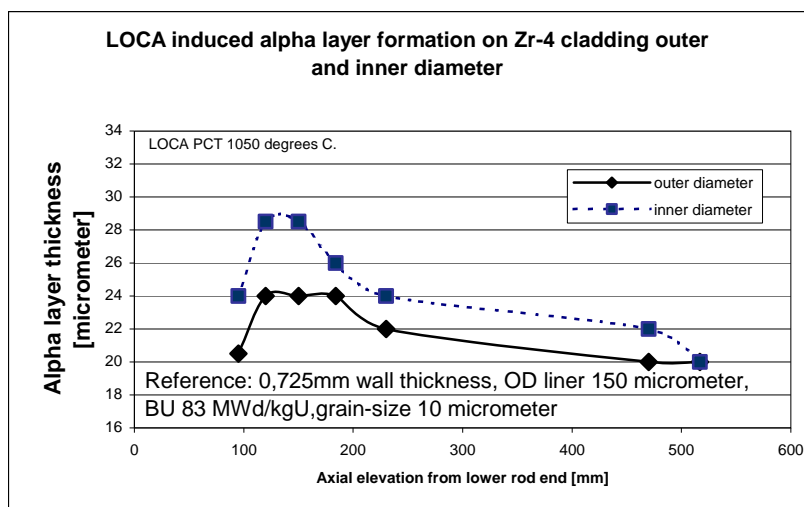
Fig. 6b Axial profile of the thickness of the alpha layer on the Zr-4 cladding (OD and ID).

Alpha layer: Oxygen, which caused alpha layer formation and cladding embrittlement, might enter from the inside diameter (ID) as well as from the outside diameter (OD) of the cladding on high-burnup fuel. On the cladding outer and inner wall a LOCA induced 20-30µm thick, oxygenrich, hard and brittle alpha layer as shown in Fig. 6 was found. The hard and brittle alpha layer is slightly wider on the inner diameter (ID) compared to the outer (OD) and the alpha layer is wider in the max balloon and burst area (OD:24 and ID:29 µm) compared to the upper part of the rod at 470 mm (OD:20 and ID:22 µm), see also Table 1 and Figs 3.5.18 through 3.5.24 in the Appendix.

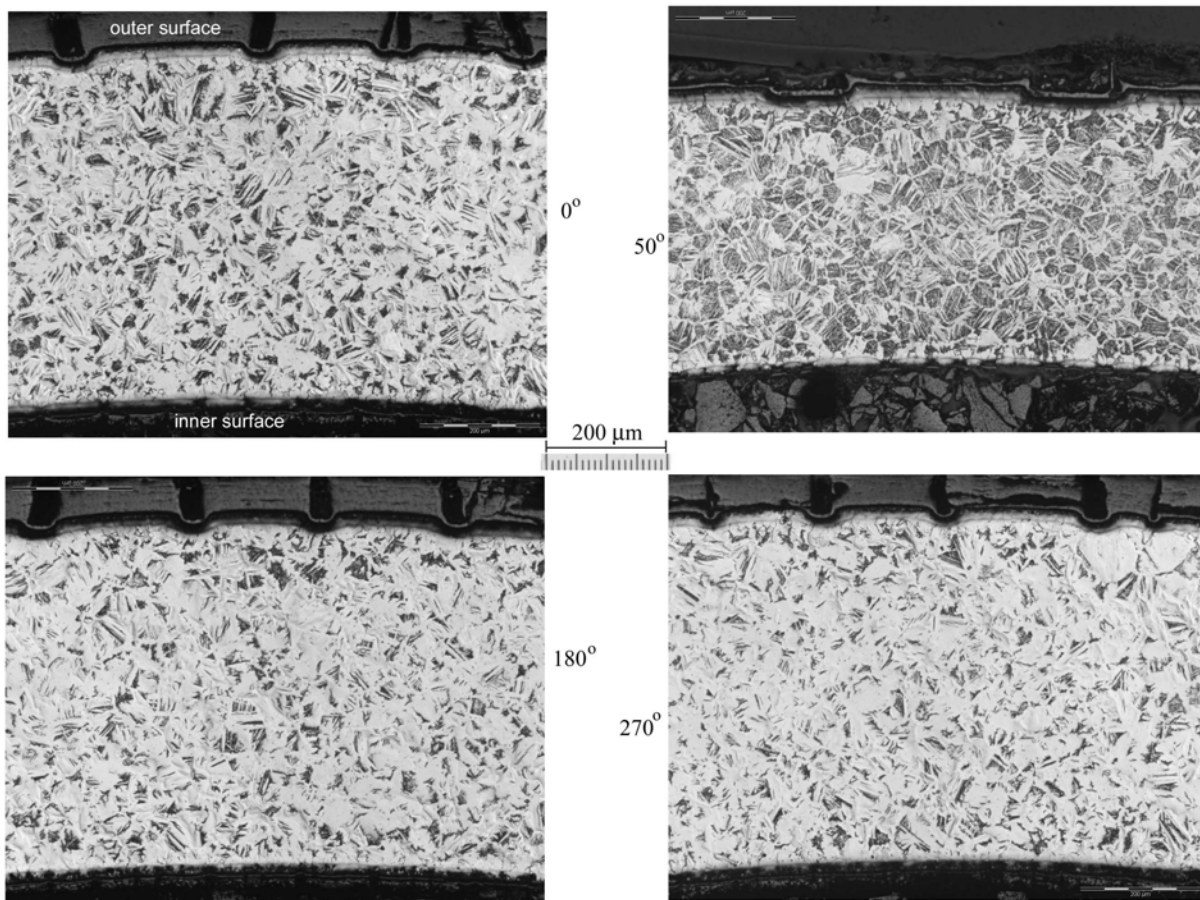
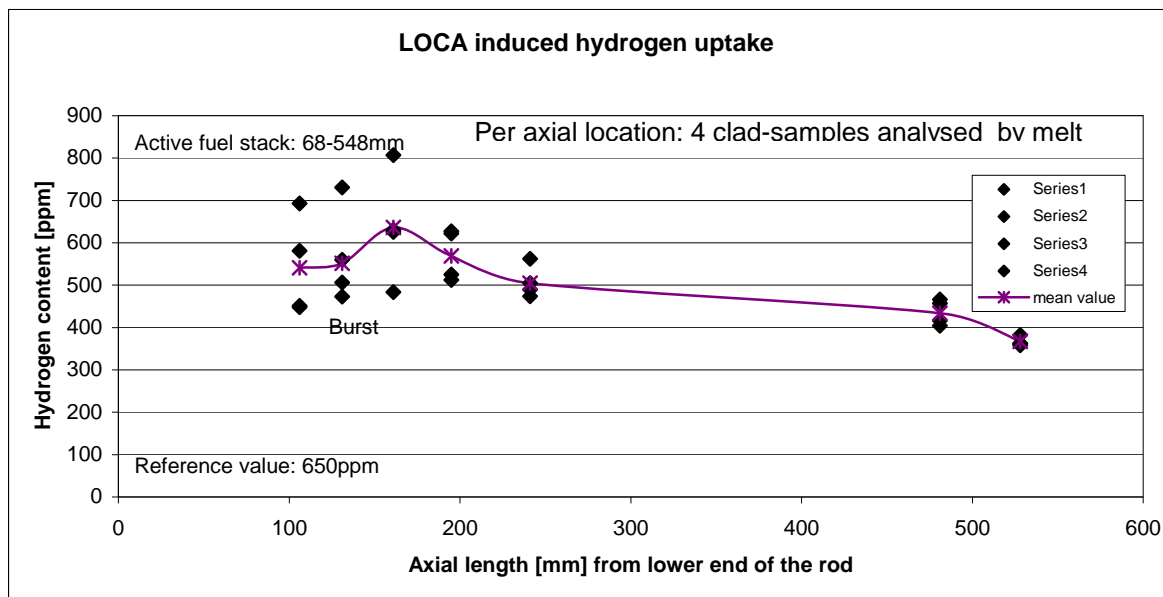
Fig. 7 shows typically arbitrary oriented hydrides in the Widmanstätten structure of the cladding. The graph in Fig. 7 represents the hydrogen content measured along the axial length of the rod. LOCA induced hydrogen uptake phenomena can be derived from the axial hydrogen content profile. From the hydrogen data the following can be stated:

Remarkable is a higher hydrogen content analysed in the samples from the balloon zone in the lower part of the rod, than elsewhere. Actually, the axial profile for hydrogen has the same shape and characteristics as the LOCA induced axial profile for the cladding diameter.

Further, with respect to the hydrogen concentration distribution as function of the angular orientation in the cladding a scatter of the measured values as function of the angular orientations was observed. A significantly larger scatter/spread was observed for the hydrogen data from the samples from the balloon zone than for the data from the samples located elsewhere in the rod. This means in the balloon zone a larger variation in the hydrogen uptake in the cladding circumference was found than elsewhere in the cladding.

Fig. 7 Typical arbitrary oriented hydrides in the Widmanstätten structure of the cladding as seen in a cross-section from the balloon zone. The LOCA induced hydrogen uptake is illustrated in the hydrogen content profile measured along the axial length of the rod.

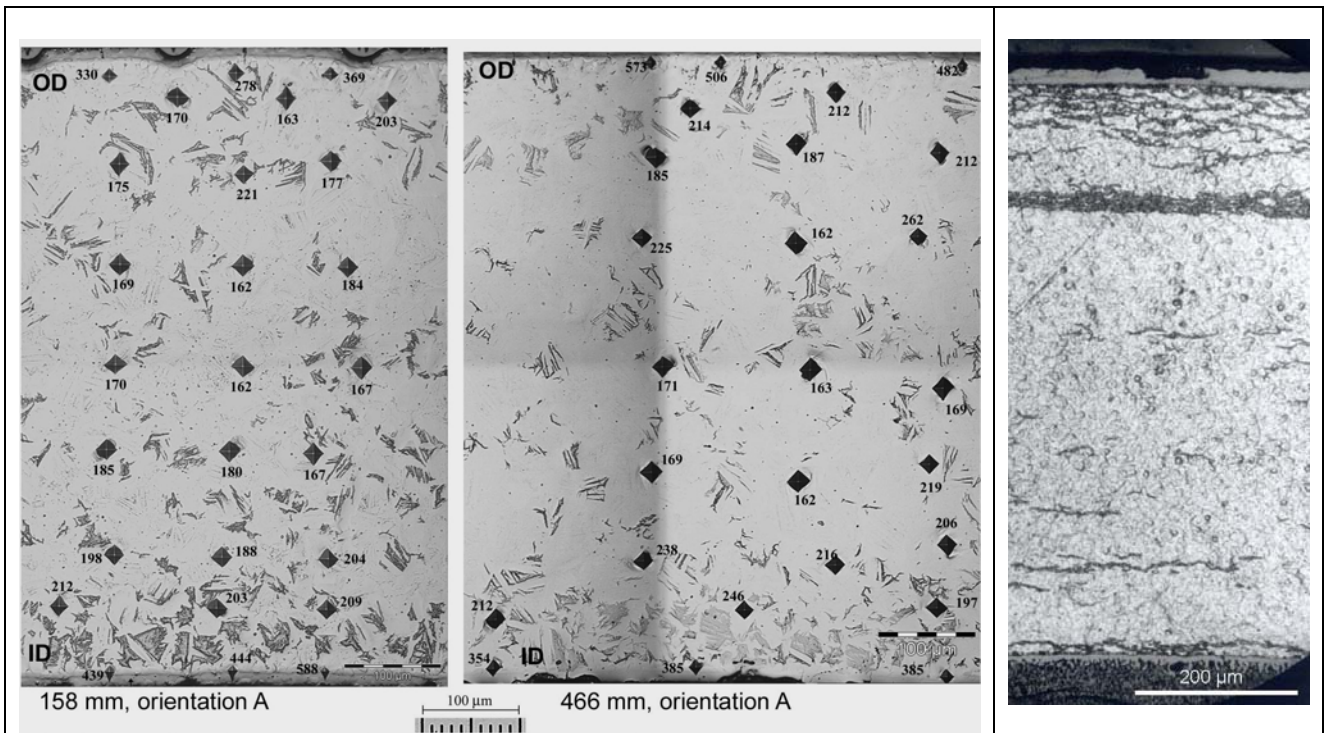
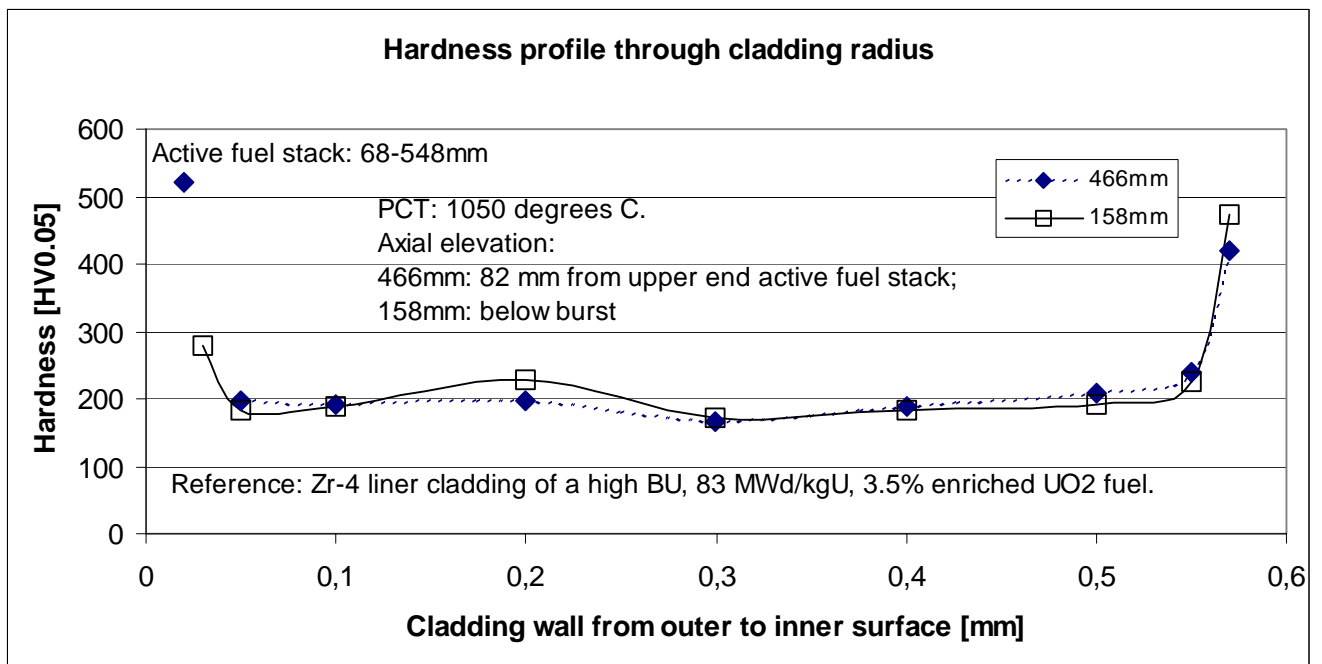
Hardness: Series of hardness measurements in the cladding radii on etch polished cross-sections were done, namely below the burst opening (158 mm) and well above the burst opening (466 mm). The hardness indents were done by a Vickers diamond indenter [HV_{0.05}] and a load of 50 g. The hardness of the high burnup, LOCA tested Zr-4 cladding showed after a temperature excursion to 1050°C in most of the cladding radius hardness values within 170 and 200 HV_{0.05}. Higher values were found in the alpha layer. The alpha layers were observed at the cladding outer (520HV_{0.05}) and inner surface (420HV_{0.05}). The measured hardness values are listed in Table 2 and the hardness profile and the respective cladding radii are shown in Fig. 8 and the Appendix.

The hardness profiles, namely from the cladding outer to the cladding inner surface showed a slight asymmetry. The asymmetry of the hardness values is affected by the 150 µm thick liner on the cladding OD.

Fig. 8 Hydrides (right: before (reference PIE) and left: after LOCA), hardness indents and profile in cladding radius. Sampling locations were towards the upper end active fuel stack (466 mm) and above the upper end burst [158mm]

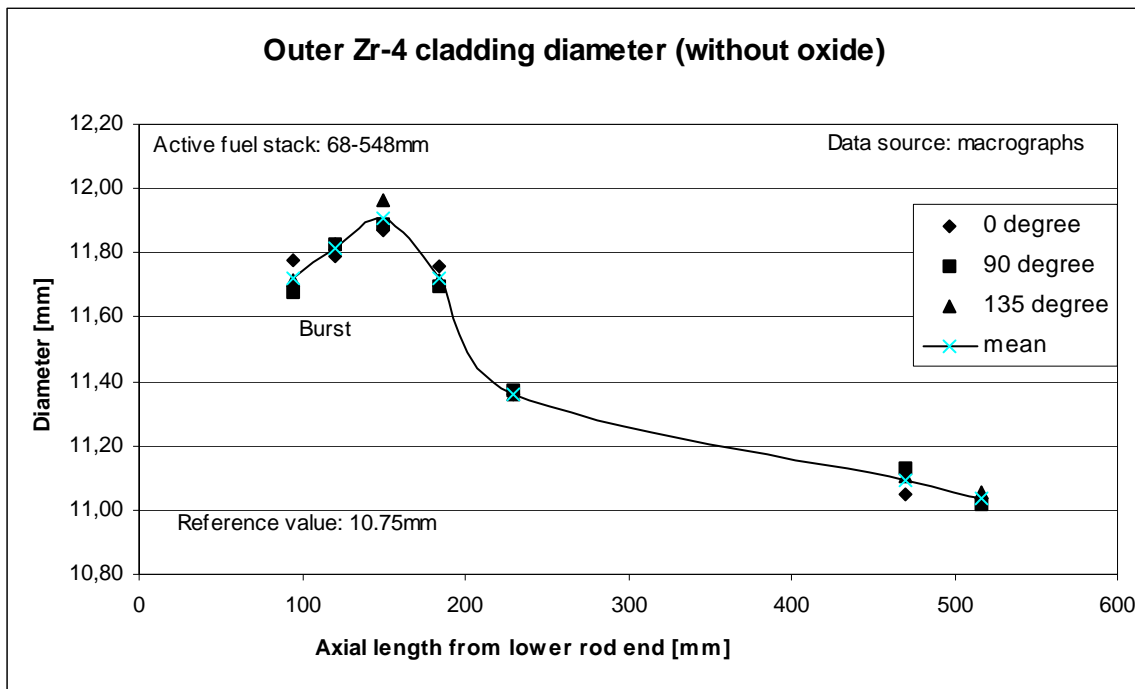
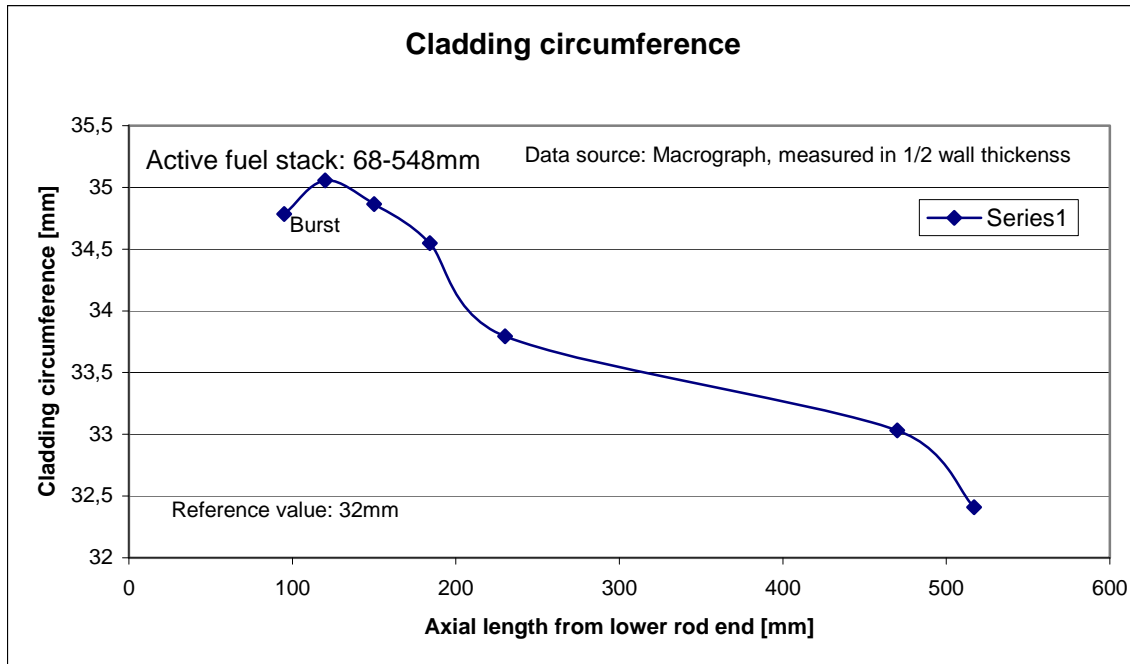
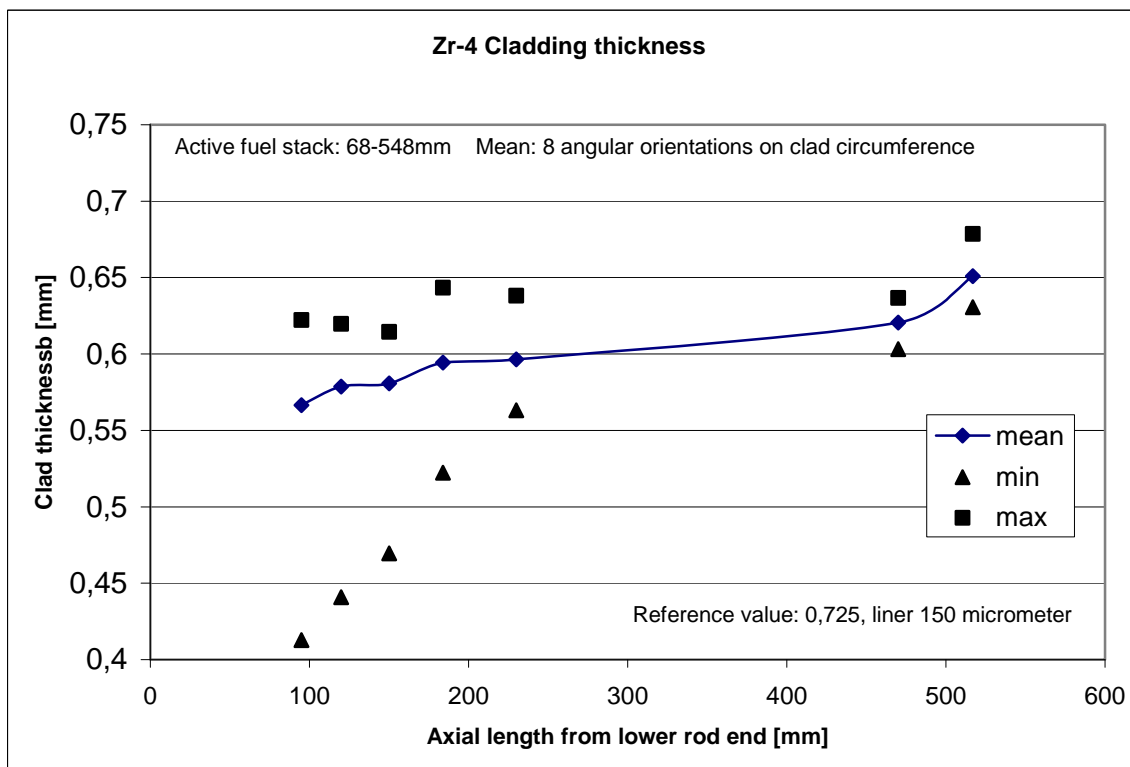
Cladding distension (hoop strain), wall thickness reduction and crack opening: Data for the mechanical properties of the cladding e.g. cladding distension (hoop strain), wall thickness reduction and crack opening were measured and are listed in Table 3 and plotted as axial profiles in Fig.9.

The cladding diameter measurements on IFA-650.5 show a relatively small strain in the rupture region, but they also show a relatively large strain along almost the whole length of the test specimen.

Fig 9. Axial profiles for diameter increase, cladding circumference (Hoop strain profile), cladding thickness / wall reduction.

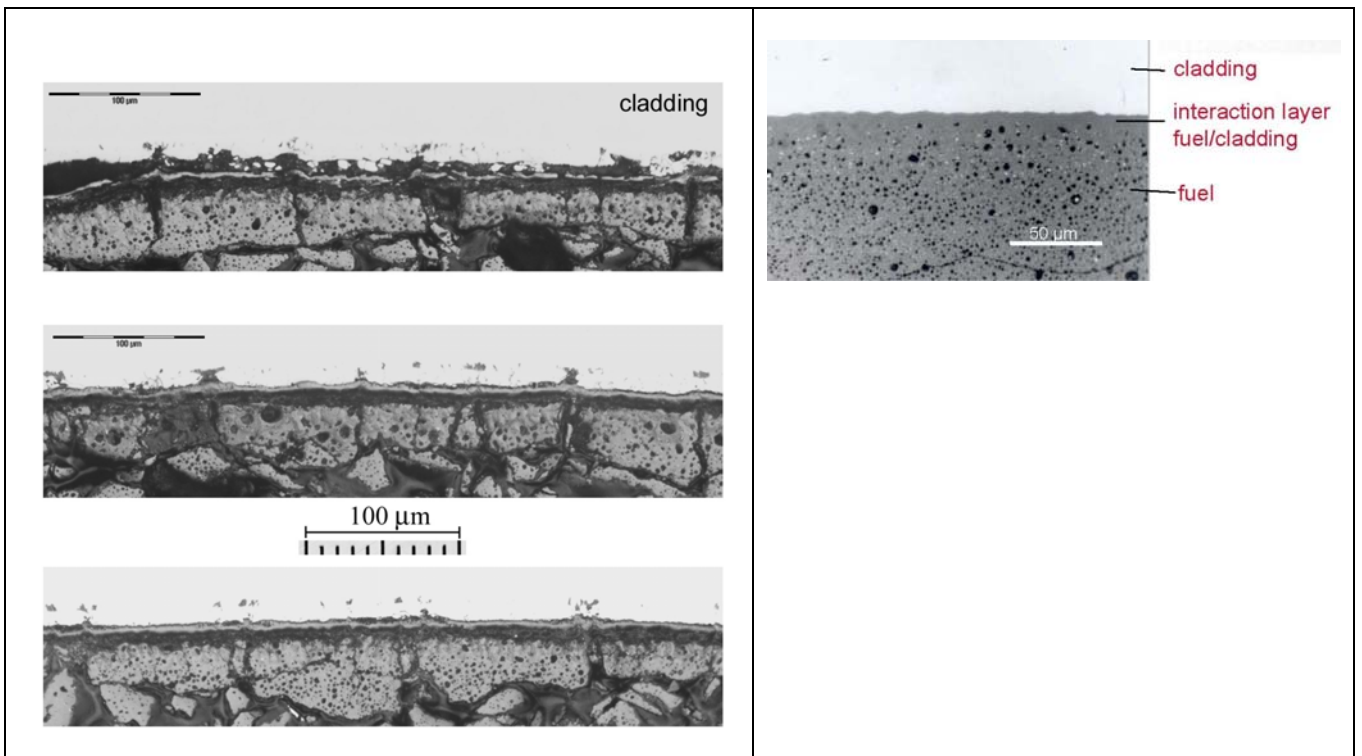
Fuel-clad bonding, radial cracks in ID oxide and in the fuel rim were observed, see Fig 10. The fuel had typically a fragmented HBU rim structure, characterized by micrometer size pores, sub-micrometer grains.

Fig. 10 Fuel-clad bonding. The cladding ID shows radial cracked oxide and fuel with fragmented HBU rim structure. The fragments are typically elongated (right). Pre-test reference PIE (left).

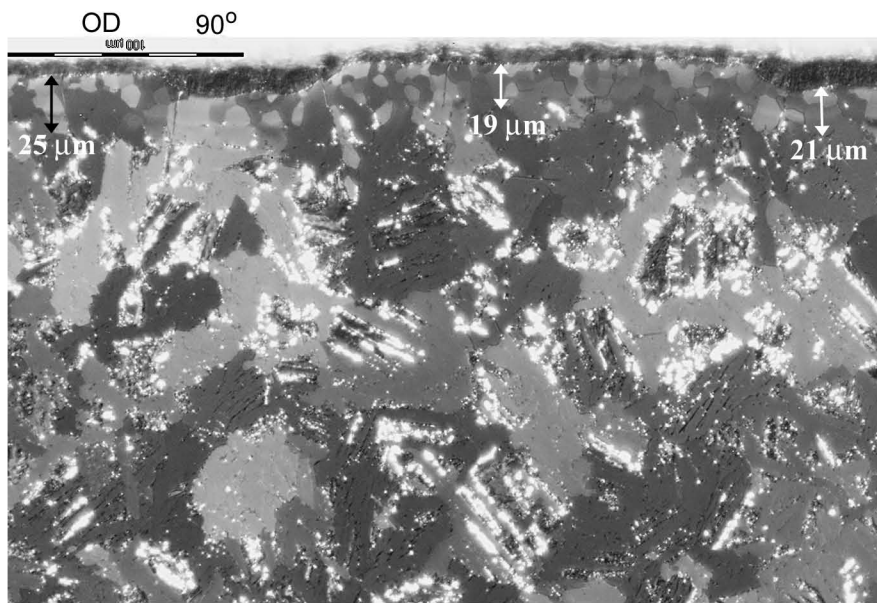
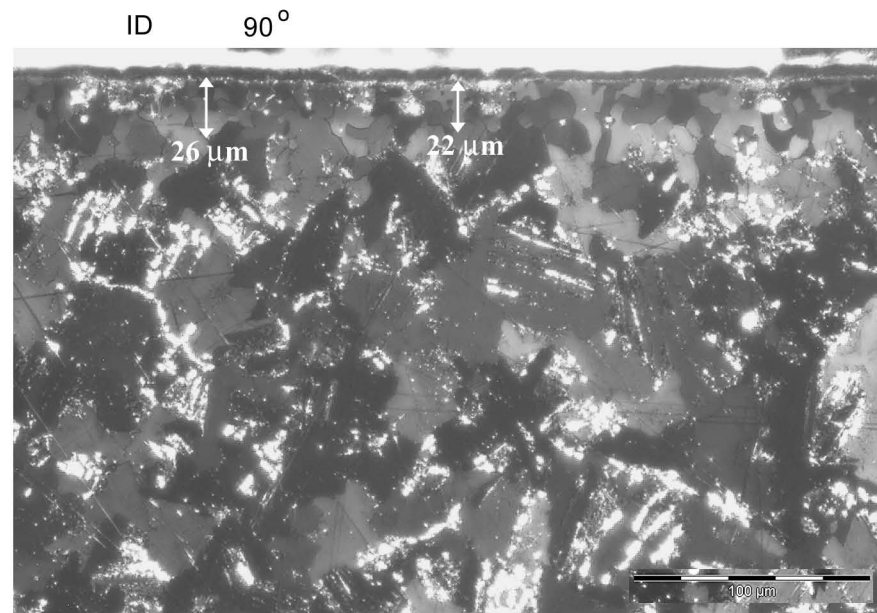
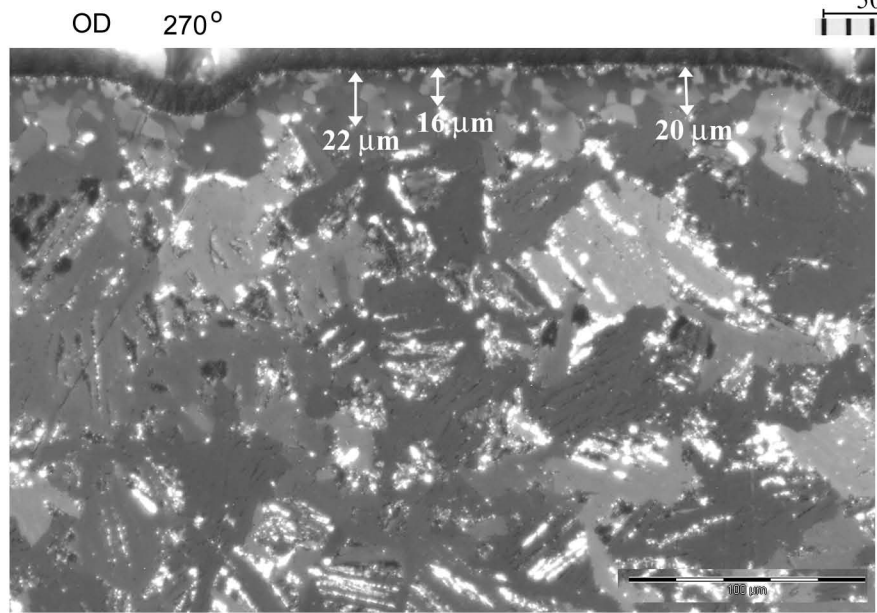
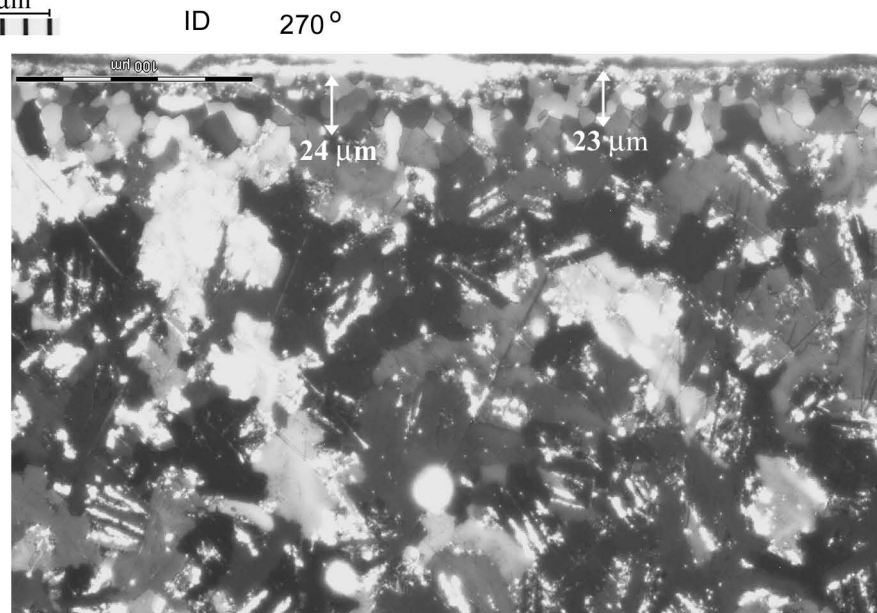
Fig. 3.5.18. Details showing the grain morphology of cladding and alpha layer on outer (OD) and inner (ID) surface. IFA-650-5 at axial position 95 mm (MC1) from lower end of fuel rod.

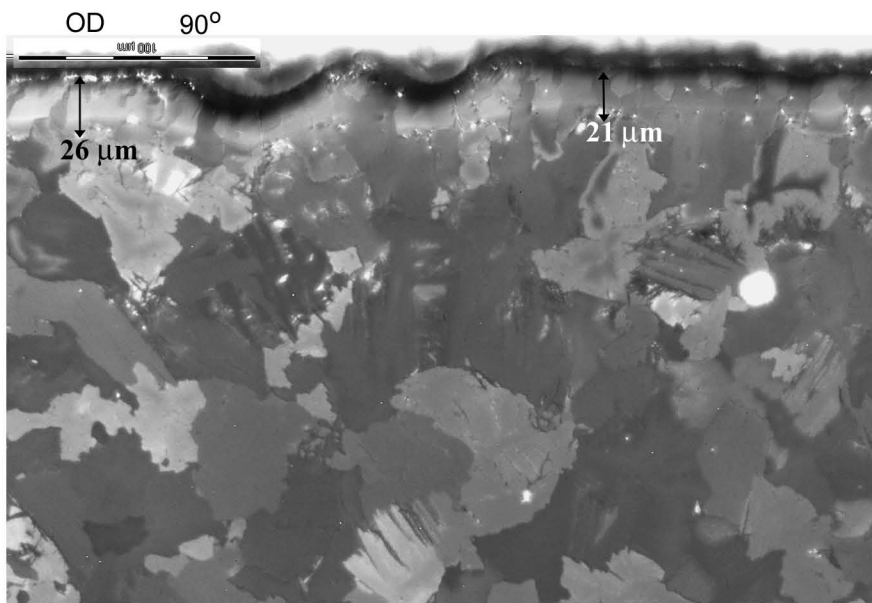
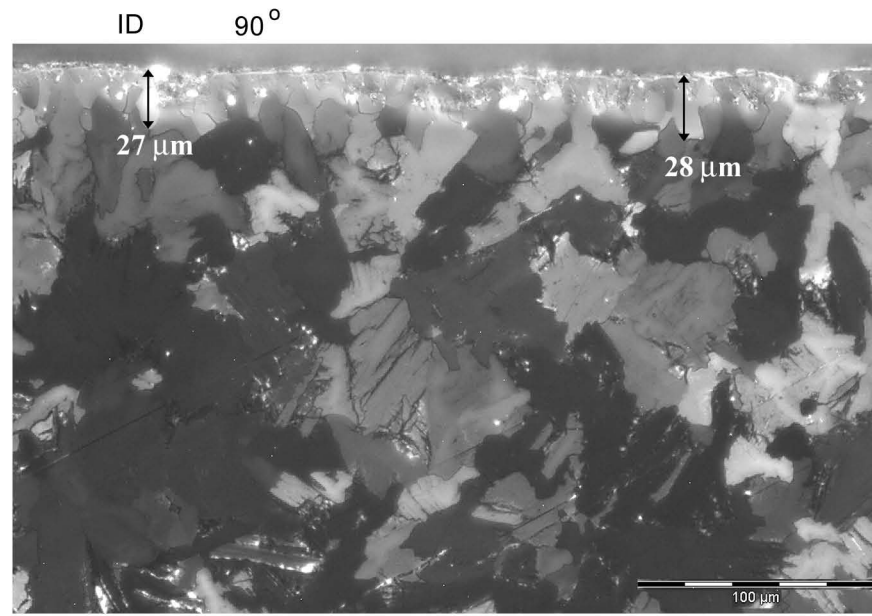
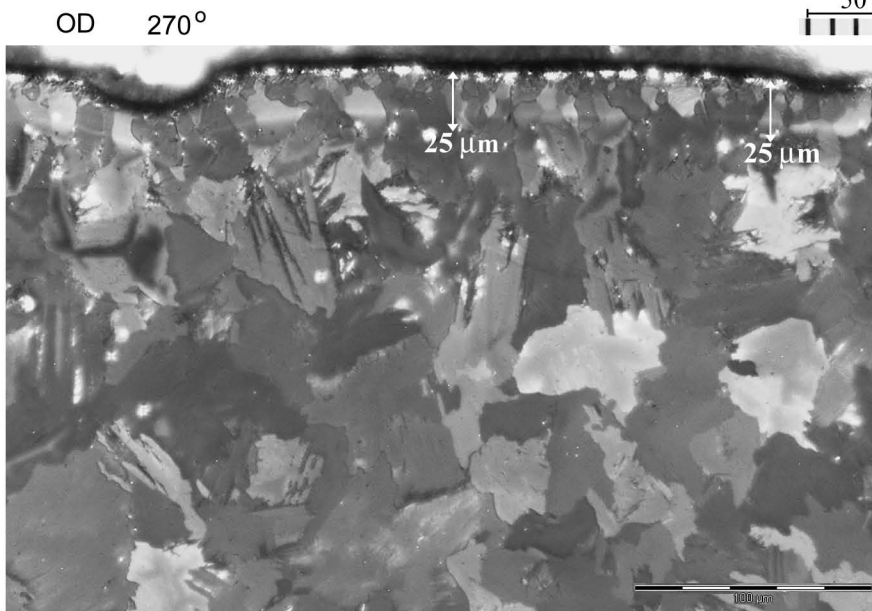
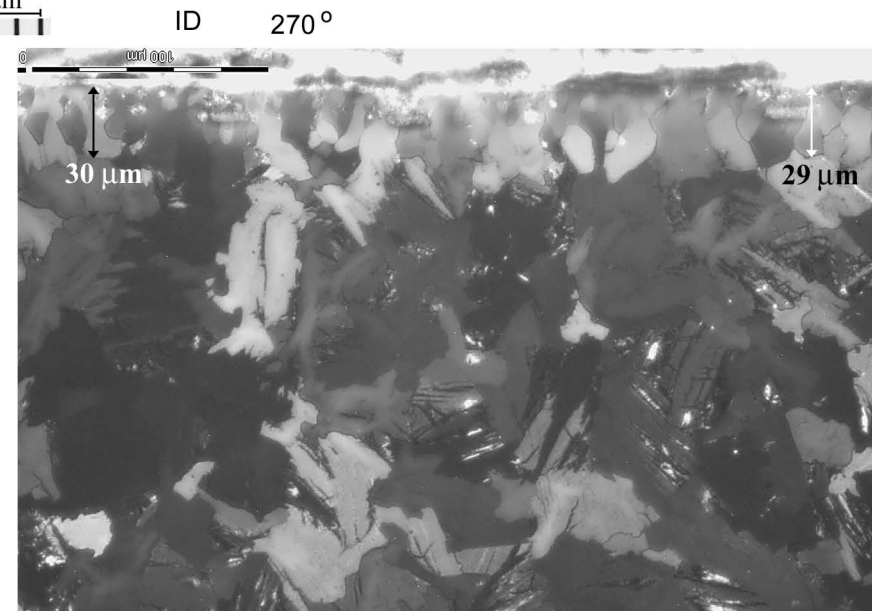
Fig. 3.5.19. Details showing the grain morphology of cladding and alpha layer on outer (OD) and inner (ID) surface. IFA-650-5 at axial position 120 mm (MC2) from lower end of fuel rod.
