LOCA TESTING OF HIGH BURNUP PWR FUEL IN
THE HBWR. ADDITIONAL PIE ON THE
CLADDING OF THE SEGMENT 650-5.

Address Telephone Telefax	KJELLER NO-2027 Kjeller, Norway +47 63 80 60 00 +47 63 81 xx xx	HALDEN NO-1751 Halden, Norway +47 69 21 22 00 +47 69 21 22 01	open
Report number IFE/KR/E-2008/004		Date 2008-04-11	
Report title and subtitle LOCA testing of high burnup PWR fuel in the HBWR. Additional PIE on the cladding of the segment 650-5.		Number of pages 35	
Project/Contract no. and name Contract ML080150003		ISSN 0333-2039	
Client/Sponsor Organisation and reference NRC/RES		ISBN 978-82-7017-704-2 (printed) 978-82-7017-705-9 (electronic)	
Abstract <p>IFA-650.5, a test with pre-irradiated fuel in the Halden Project LOCA test series, was conducted on October 23rd, 2006. The fuel rod had been used in a commercial PWR and had a high burnup, 83 MWd/kgU. Experimental arrangements of the fifth test were similar to the preceding LOCA tests. The peak cladding temperature (PCT) level was higher than in the third and fourth tests, 1050 °C. A peak temperature close to the target was achieved and cladding burst occurred at ~750 °C. Within the joint programme framework of the Halden Project PIE wa

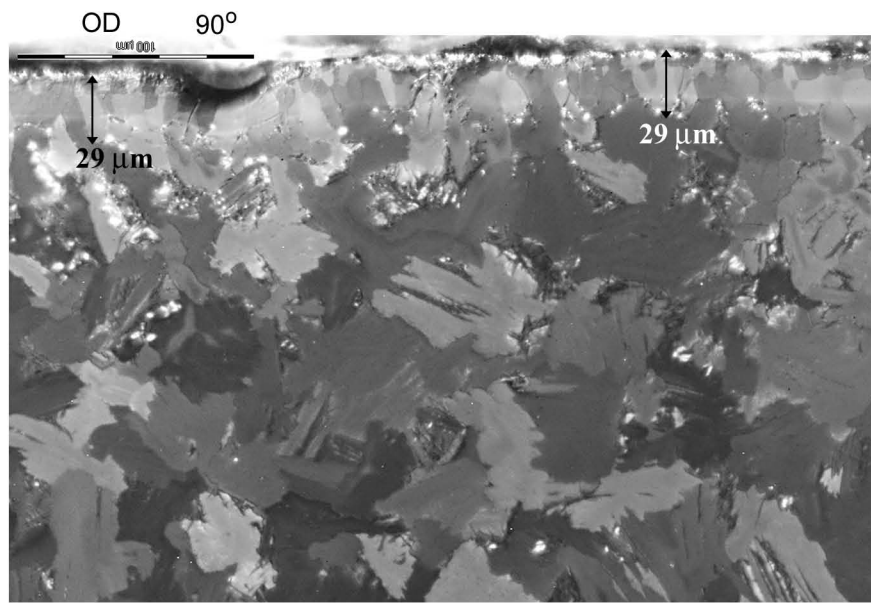
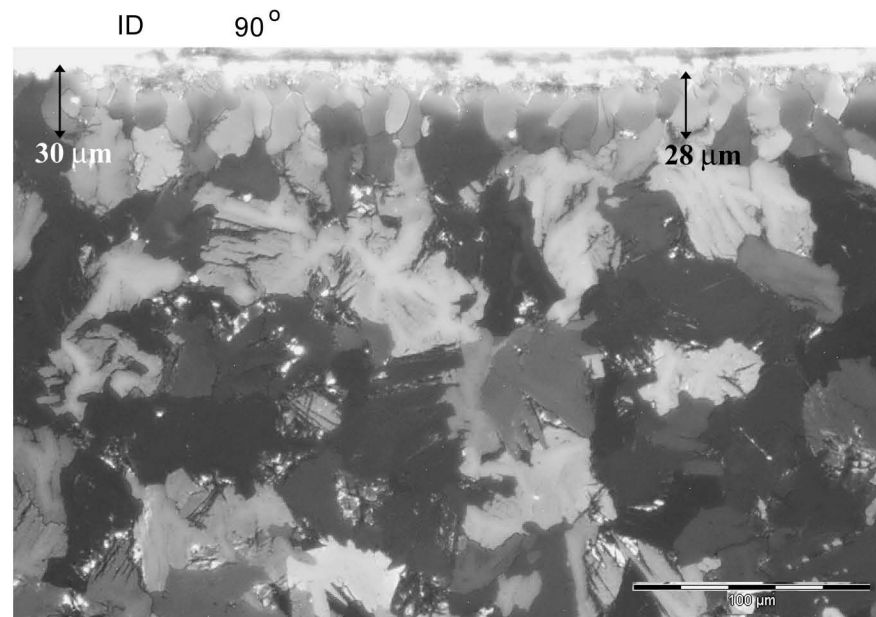
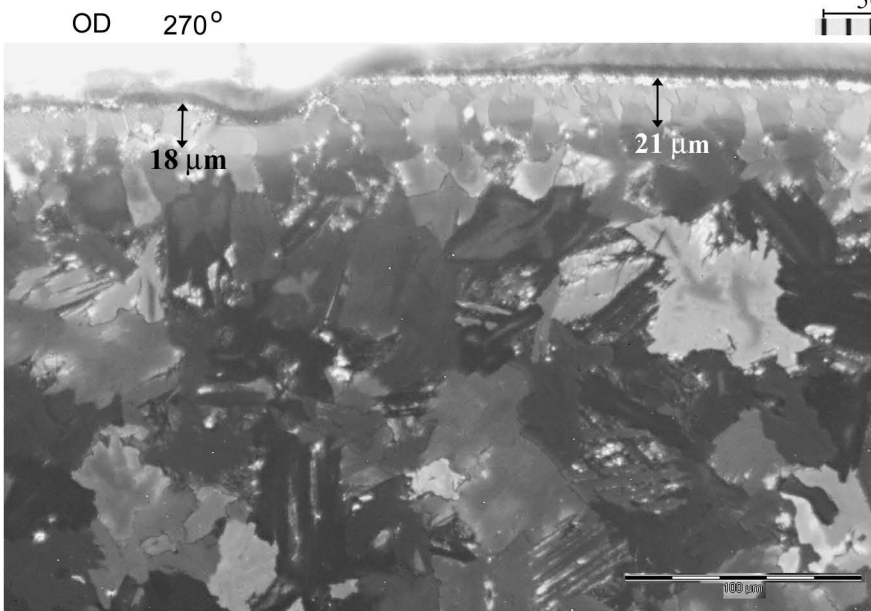
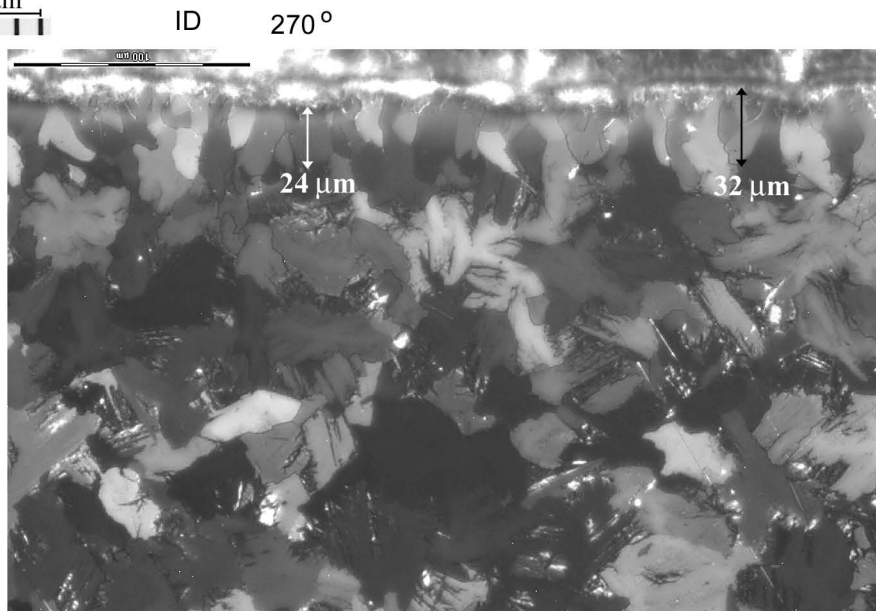
Fig. 3.5.20. Details showing the grain morphology of cladding and alpha layer on outer (OD) and inner (ID) surface. IFA-650-5 at axial position 150 mm (MC3) from lower end of fuel rod.

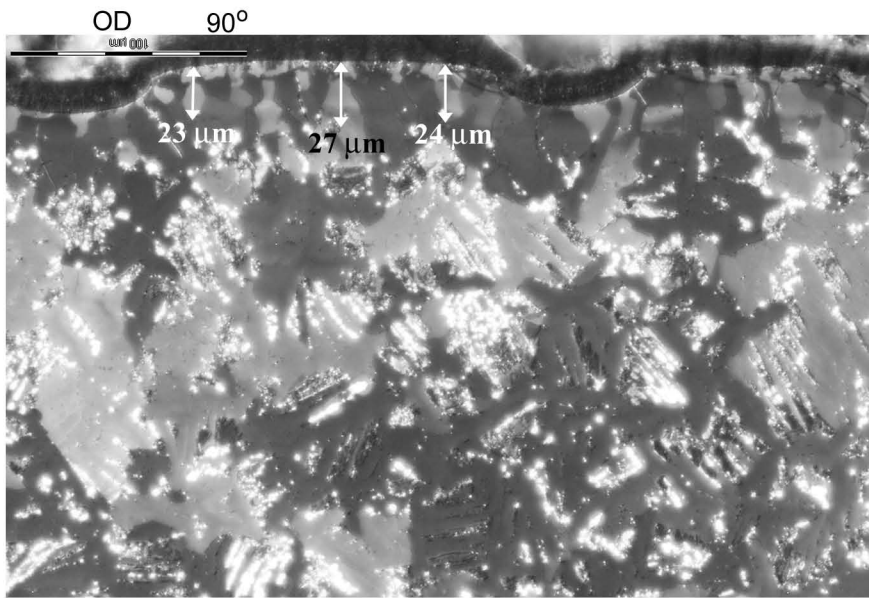
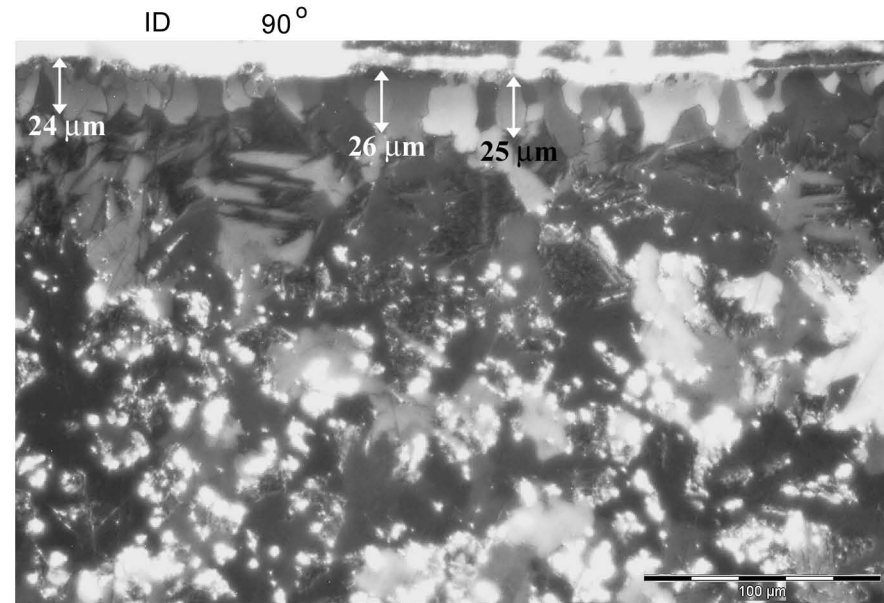
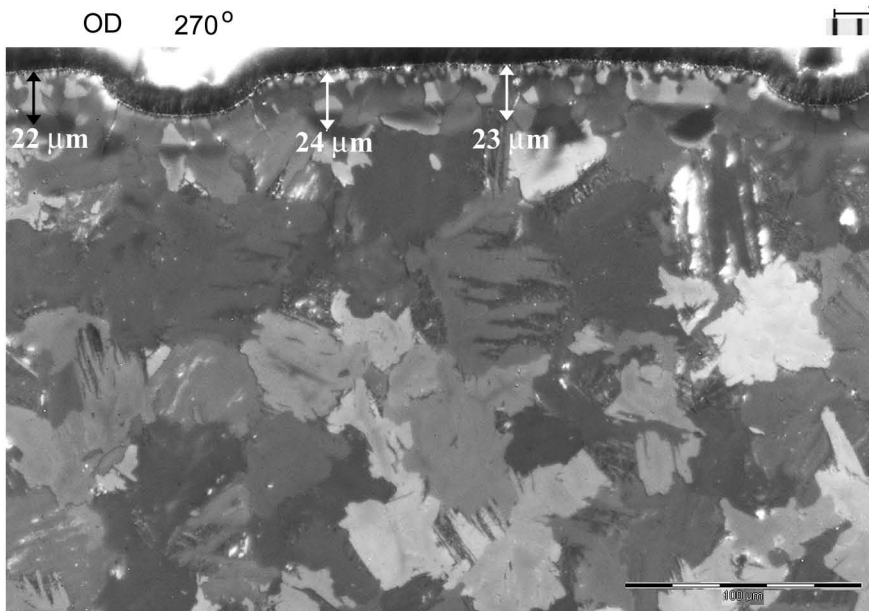
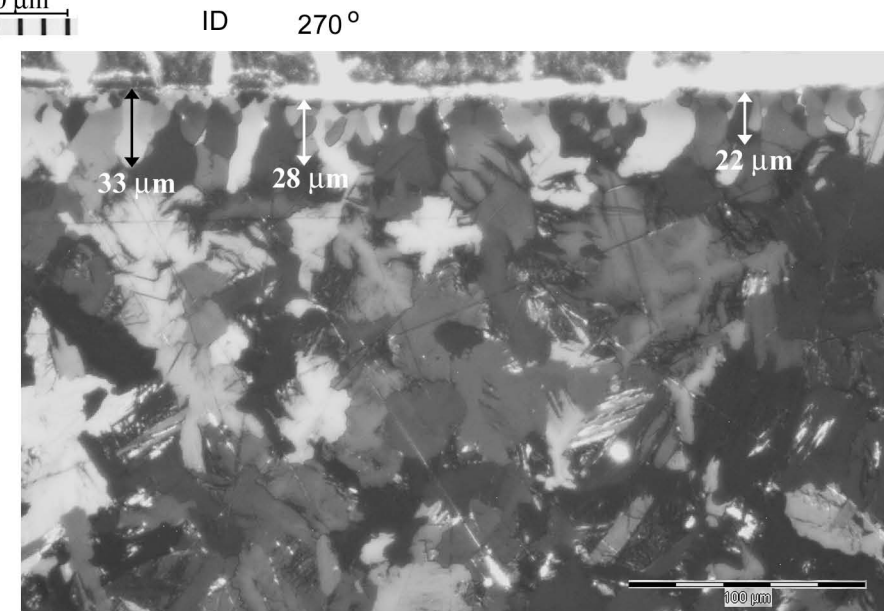
Fig. 3.5.21. Details showing the grain morphology of cladding and alpha layer on outer (OD) and inner (ID) surface. IFA-650-5 at axial position 184 mm (MC4) from lower end of fuel rod.

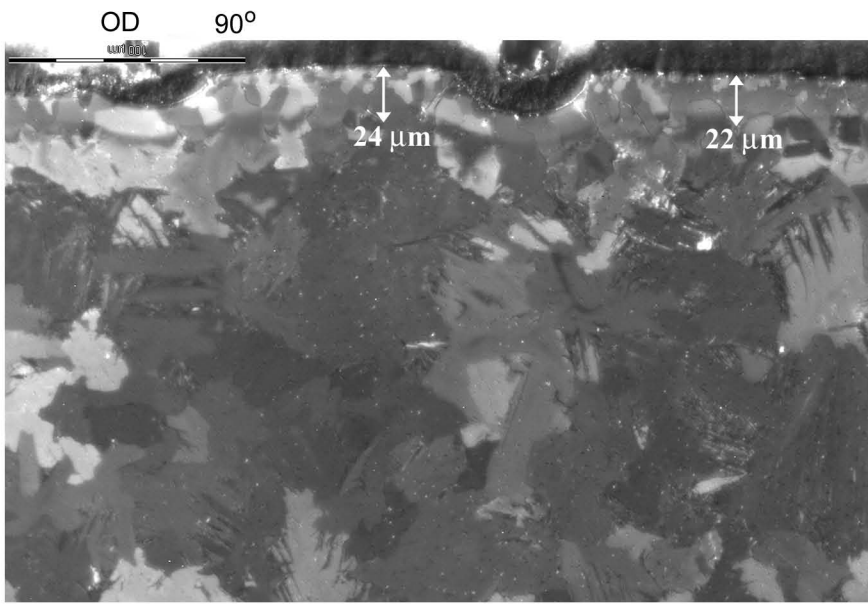
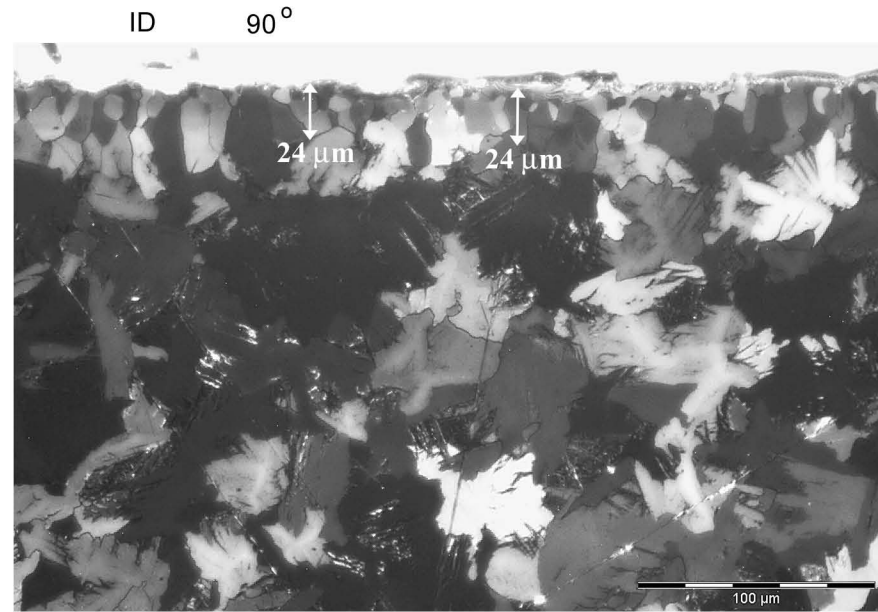
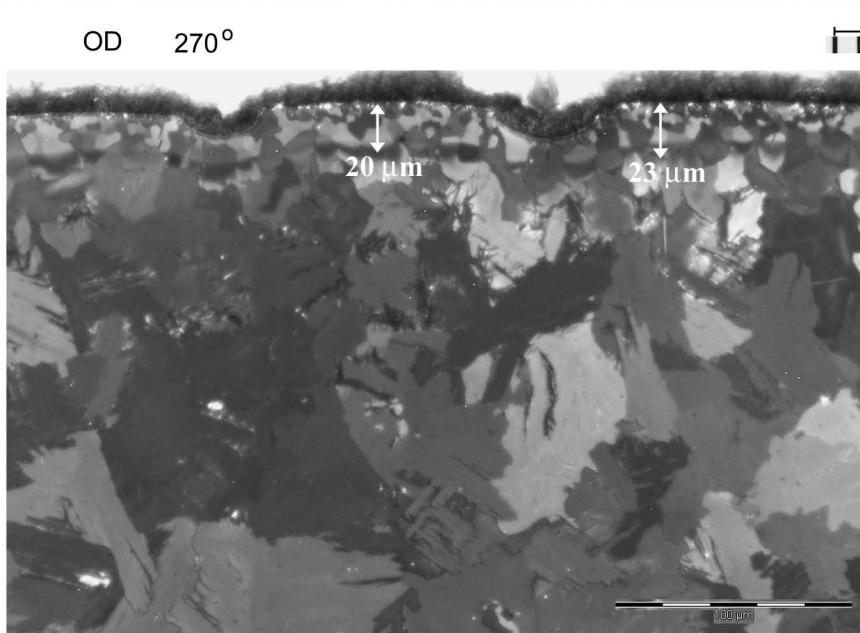
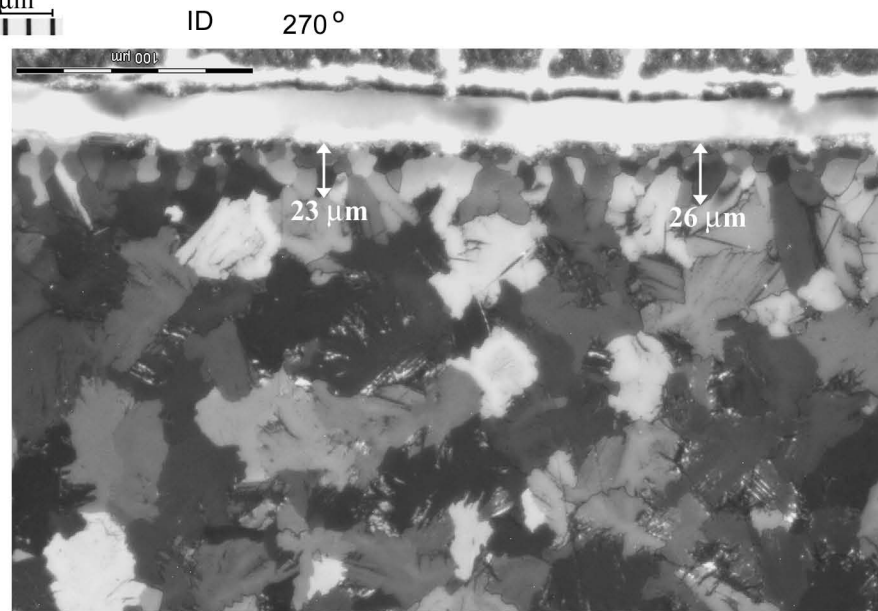
Fig. 3.5.22. Details showing the grain morphology of cladding and alpha layer on outer (OD) and inner (ID) surface. IFA-650-5 at axial position 230 mm (MC5) from lower end of fuel rod.

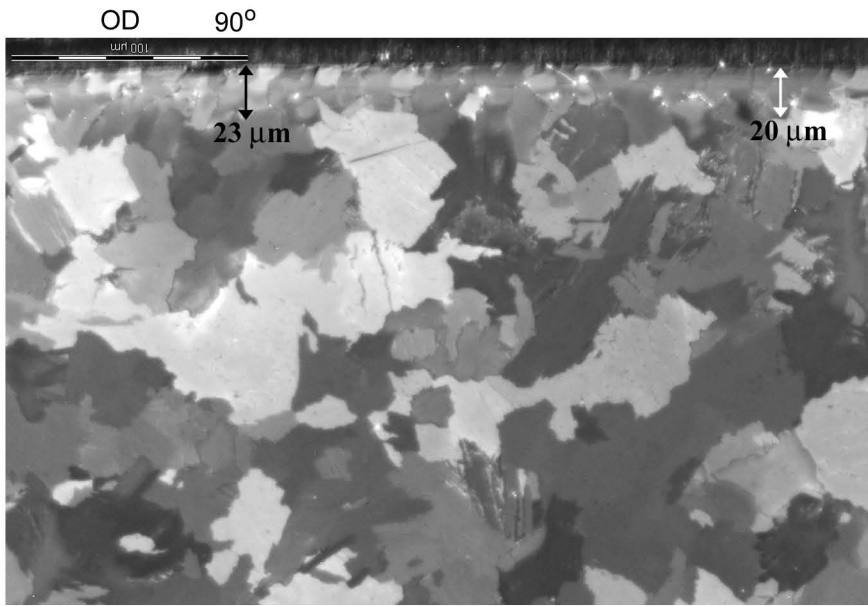
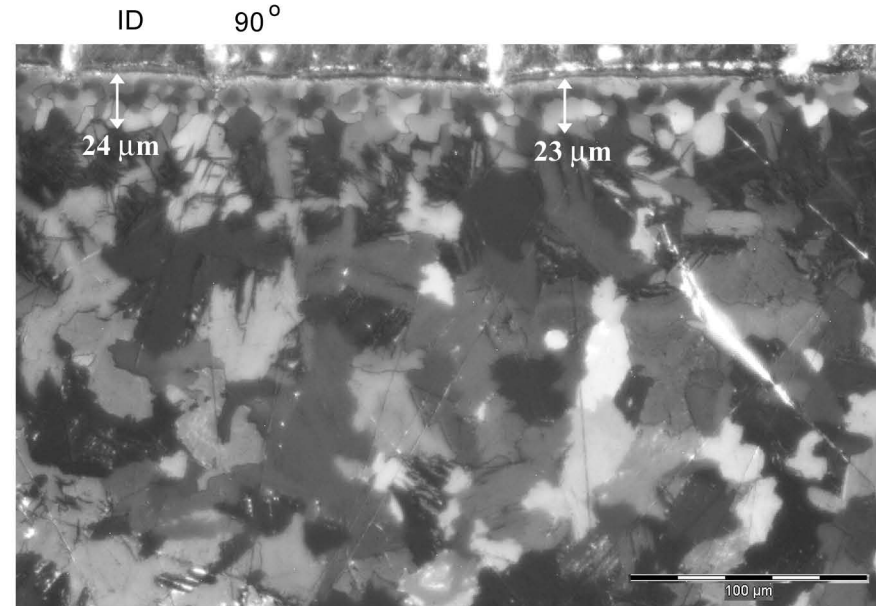
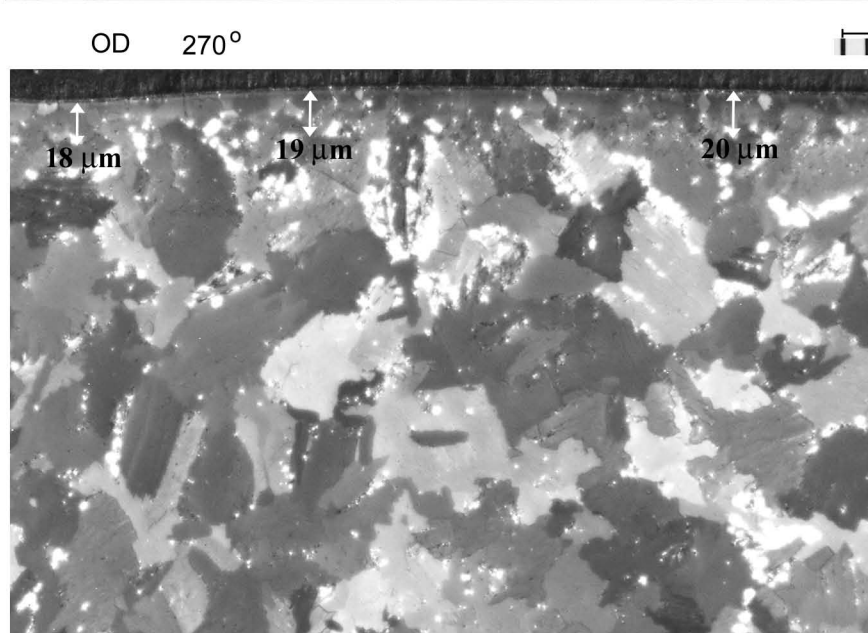
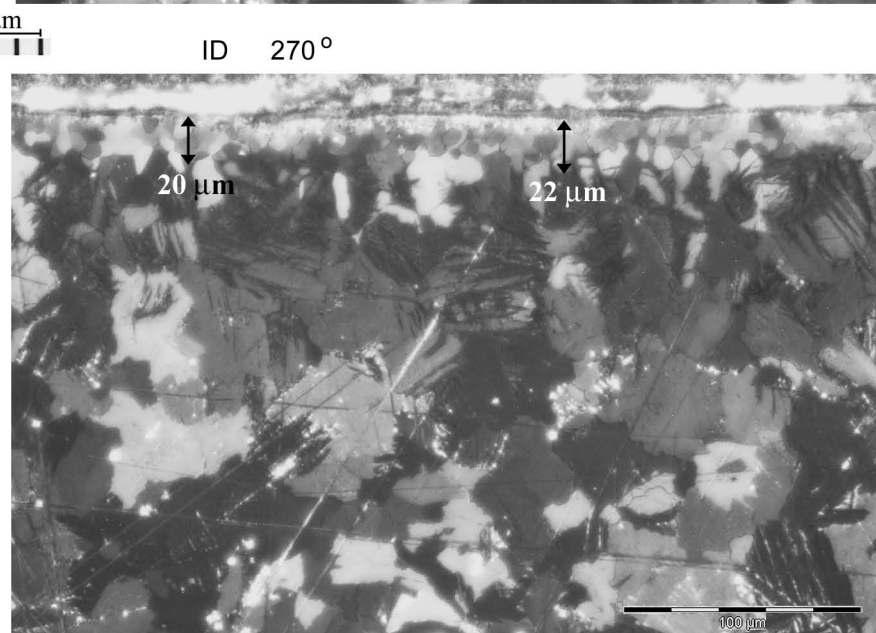
Fig. 3.5.23. Details showing the grain morphology of cladding and alpha layer on outer (OD) and inner (ID) surface. IFA-650-5 at axial position 470 mm (MC6) from lower end of fuel rod.

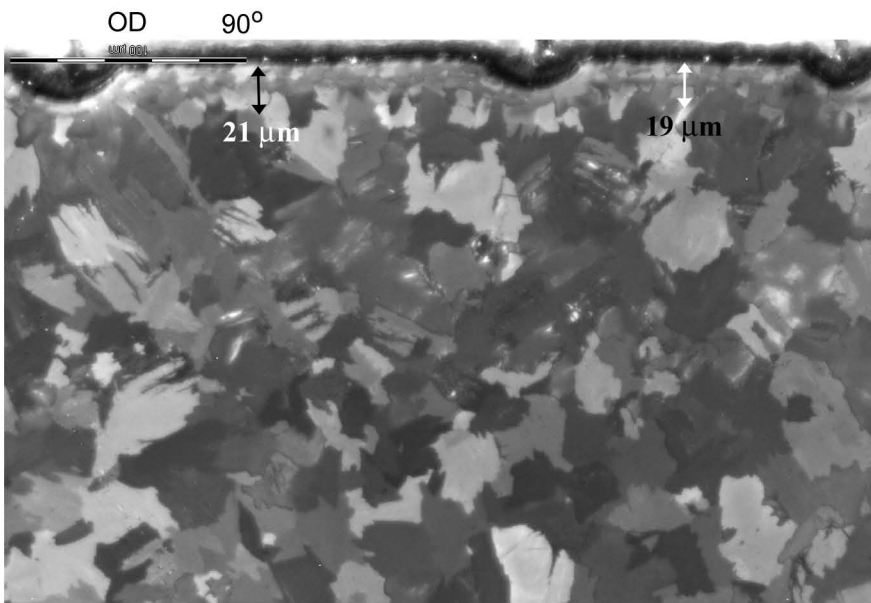
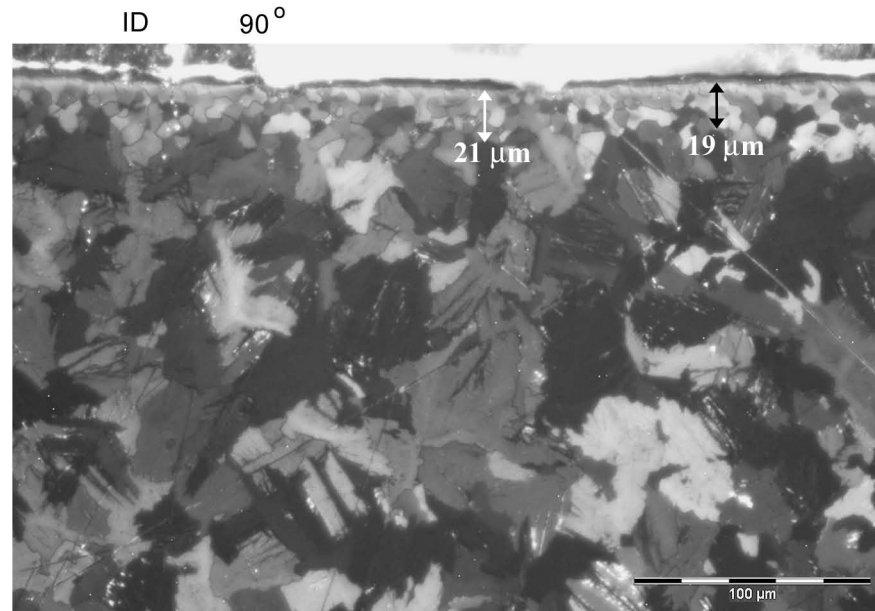
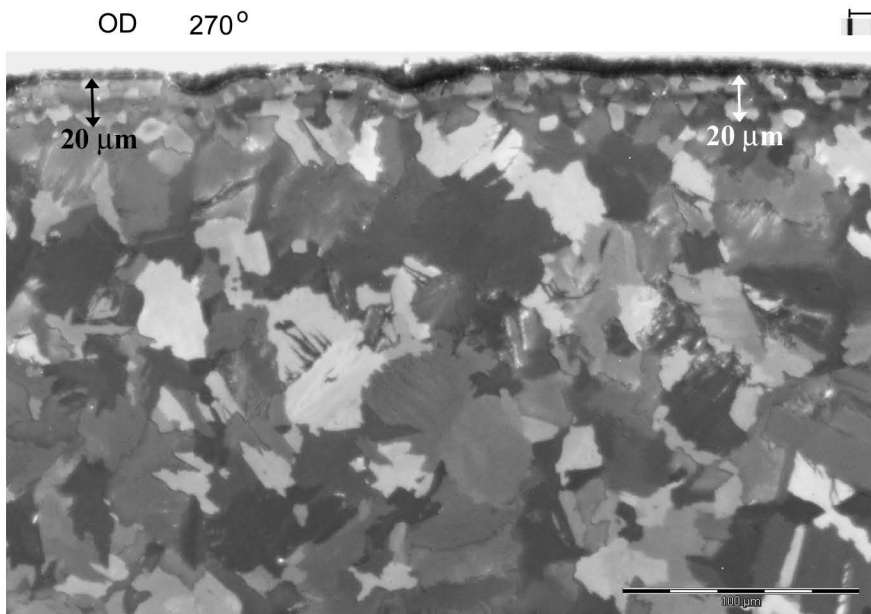
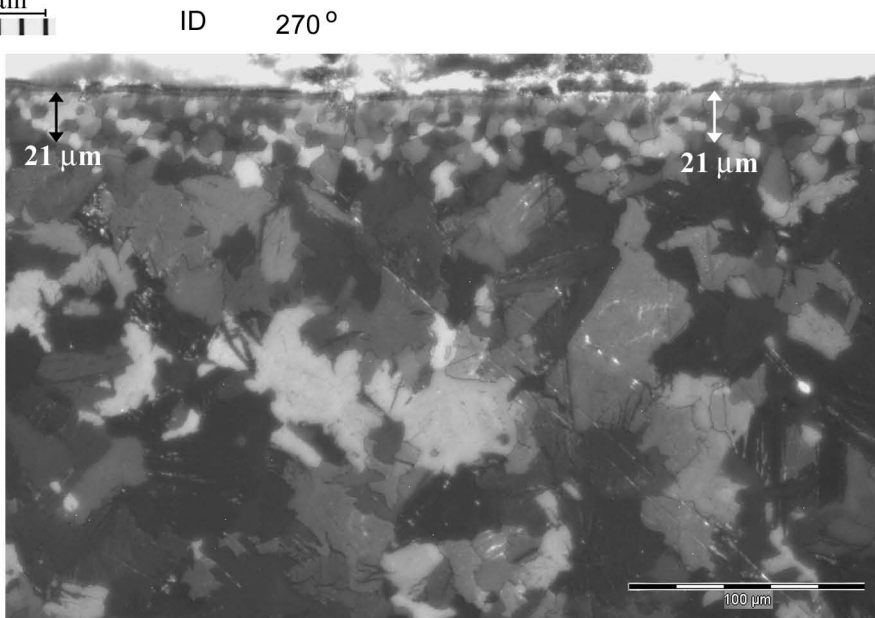
Fig. 3.5.24. Details showing the grain morphology of cladding and alpha layer on outer (OD) and inner (ID) surface. IFA-650-5 at axial position 517 mm (MC7) from lower end of fuel rod.

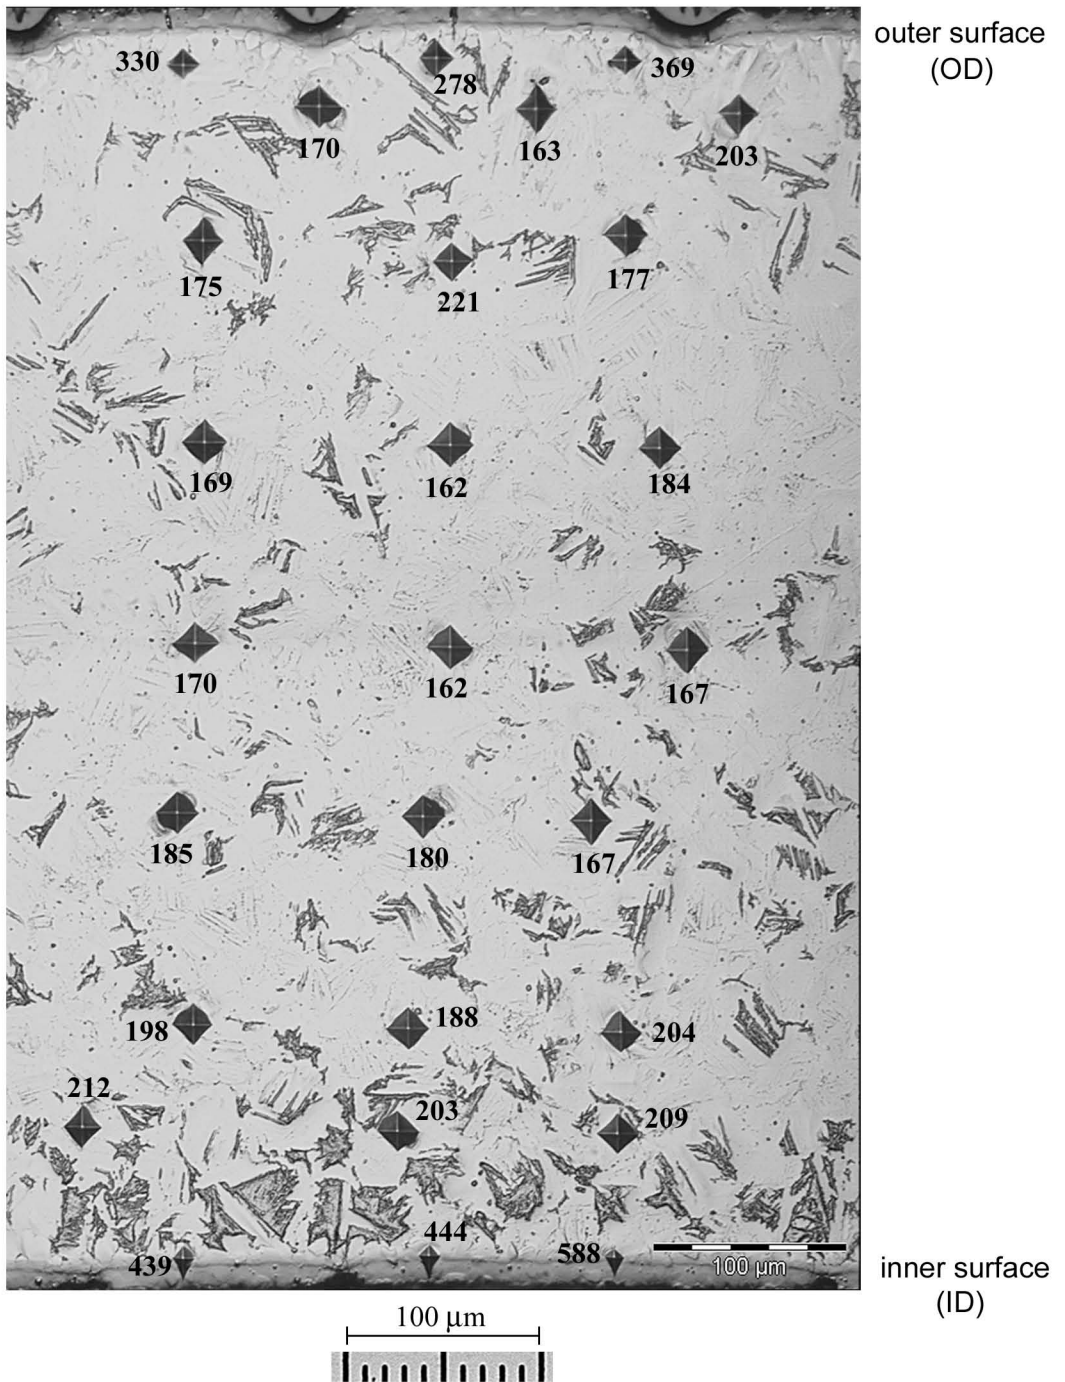
Fig. 3.5.32. Hardness measurement (HV0.05) of IFA-650-5 at orientation A and axial position 158 mm from lower end of fuel rod in etch-polished condition.

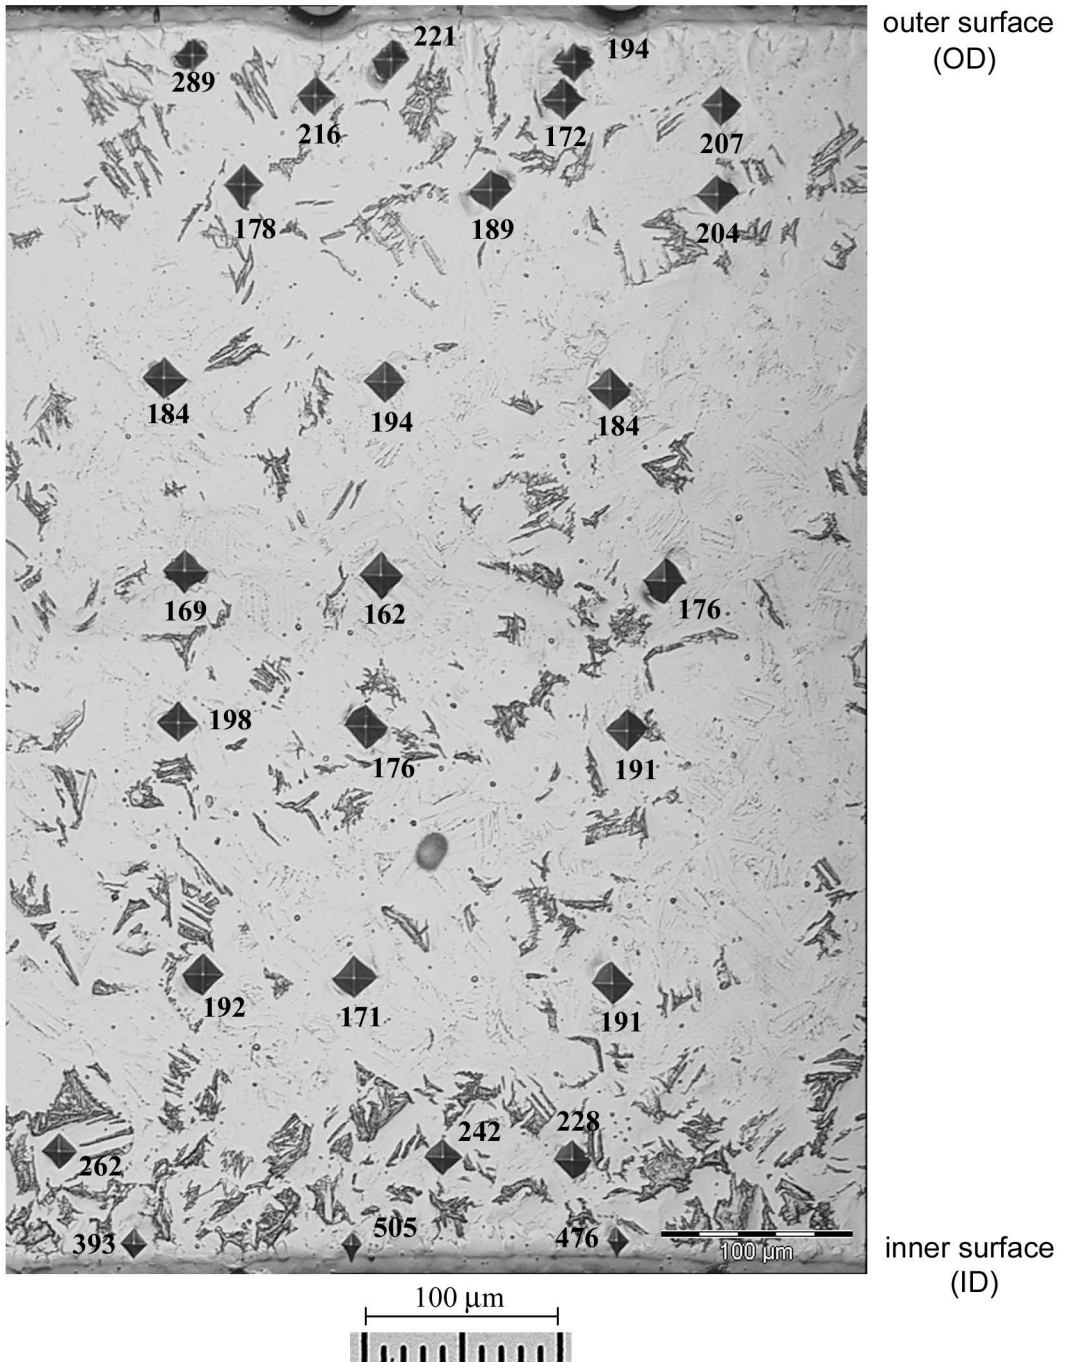
Fig. 3.5.33. Hardness measurement (HV0.05) of IFA-650-5 at orientation B and axial position 158 mm from lower end of fuel rod in etch-polished condition.

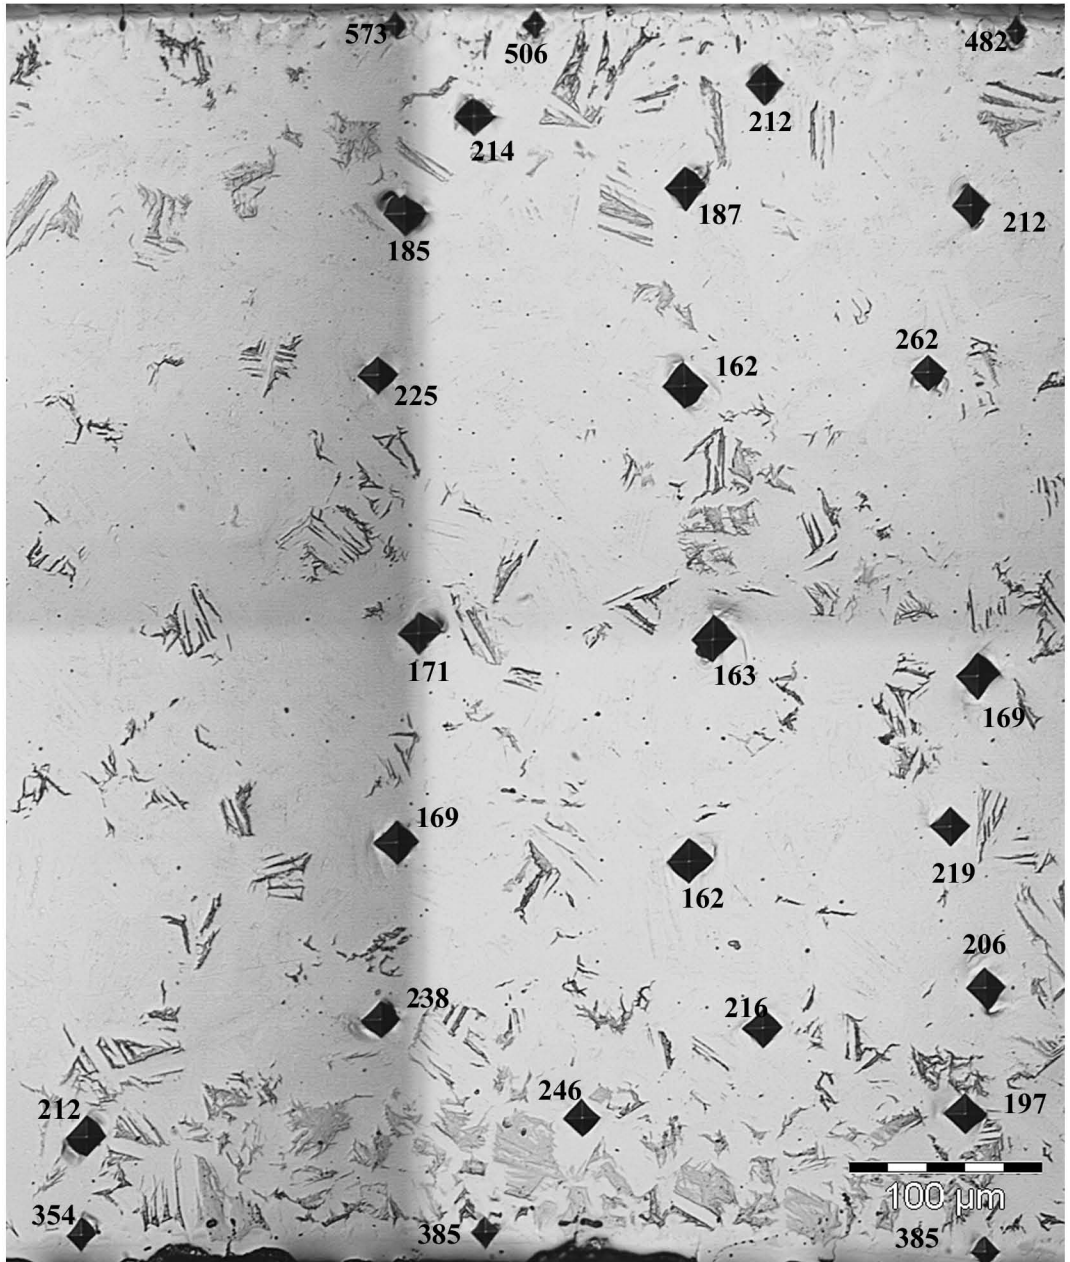
Fig. 3.5.34. Hardness measurement (HV0.05) of IFA-650-5 at orientation A and axial position 466 mm from lower end of fuel rod in etch-polished condition.

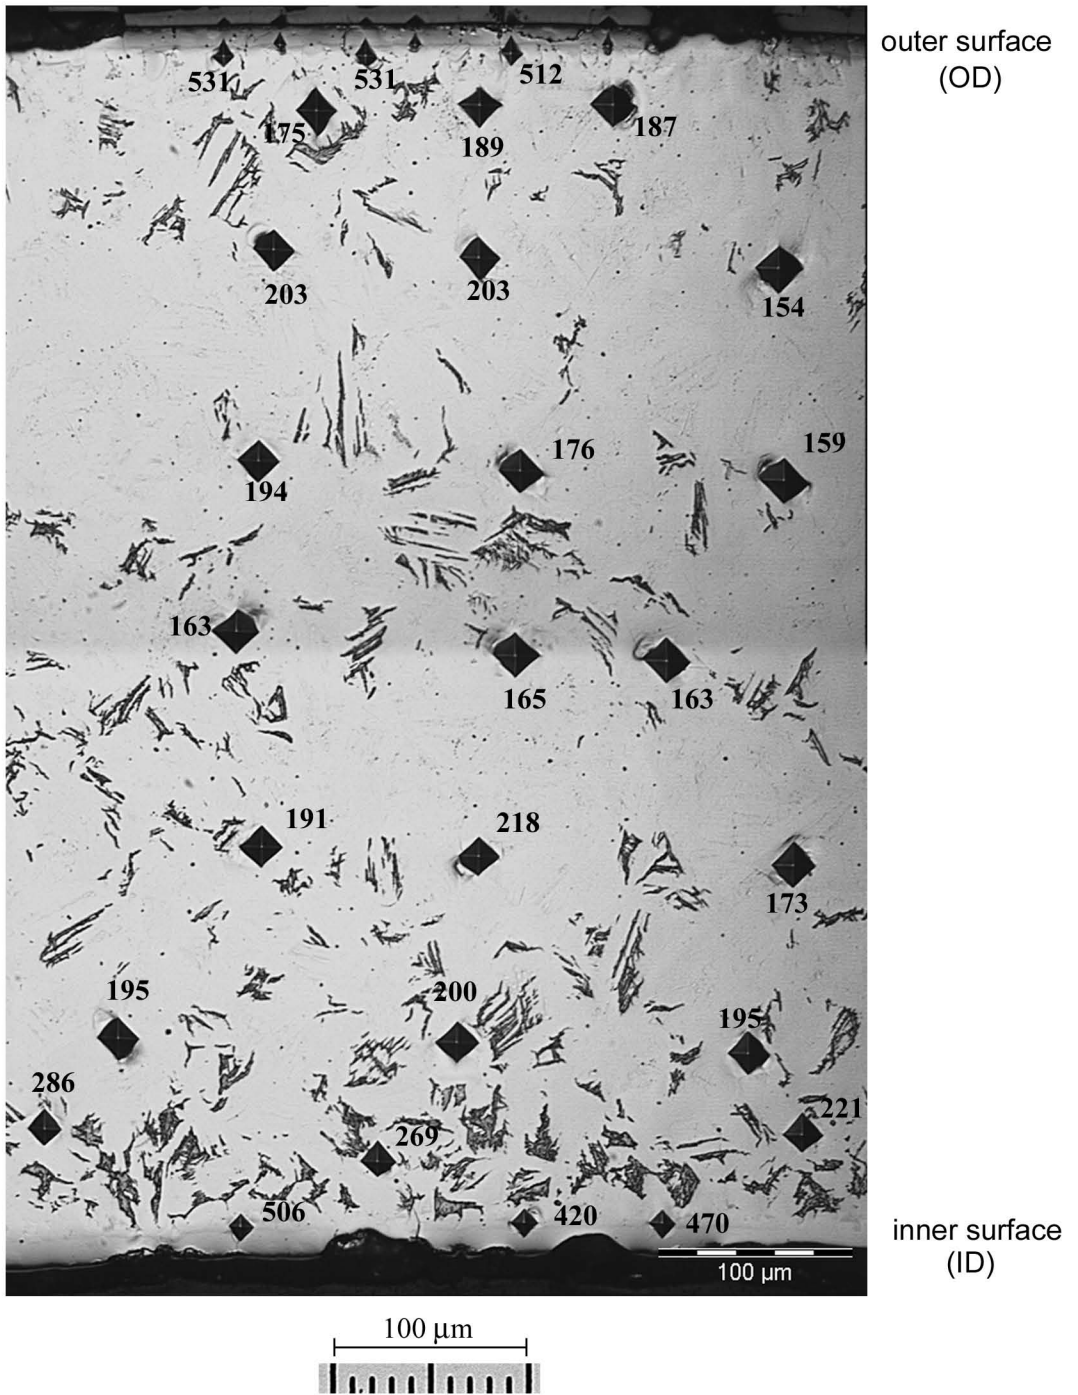
Fig. 3.5.35. Hardness measurement (HV0.05) of IFA-50-5 at orientation B and axial position 466 mm from lower end of fuel rod in etch-polished condition.
