Comparative degradation analysis of accelerated-aged and field-aged crystalline silicon photovoltaic modules under Indian subtropical climatic conditions

The understanding of the degradation modes in end-of-life (EoL) photovoltaic (PV) modules is essential to develop realistic and effective accelerated testing methods. In this paper, types of defects and degradations (D&Ds) observed in EoL field-aged modules (FAM) have been compared with the accelerated-aged modules (AAM) for their type and underlying mechanisms. For this purpose, the FAM exposed to outdoor environmental conditions for 20 years have been taken from two cities in India. The observed D&Ds in FAM were compared with modules subjected to the temperature and humidity accelerated tests as per IEC 61215-2 standards using visual inspection, electroluminescence imaging, microscopic inspection, and current-voltage measurement. Encapsulant discoloration and delamination were the dominant modes of degradation observed in the FAM from both locations. Further, thermo-mechanical and mechanical breakages were more pronounced qualitatively under accelerated testing conditions. On the other hand, different types of chemical-induced

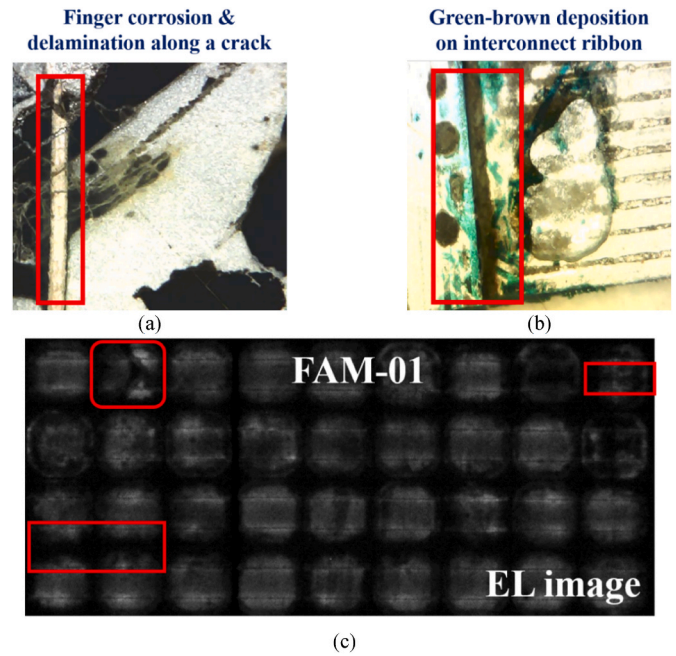
In addition, microscopic images of the FAM-01 have also been taken for in-depth defect analysis as shown in Fig. 3 (a) and Fig. 3 (b). The green and brown deposits have been found on the interconnect ribbons and fingers. Similar deposits are also found on the interconnect ribbon connecting to the junction box. Also, the corrosion on the fingers of the solar cells has been observed at multiple locations and impact cracks or small area cracks are also found in the cells. These defects in the FAM-01 can also be traced from its EL image, where regions having these defects are appearing as dark regions (encircled in red) in Fig. 3 (c).

Fig. 3. Microscopic images at 400× zoom of (a) finger corrosion along a crack, (b) corrosion at interconnect ribbon, and (c) EL image of FAM-01 taken at I_{sc} of the module for a duration of 3 s.

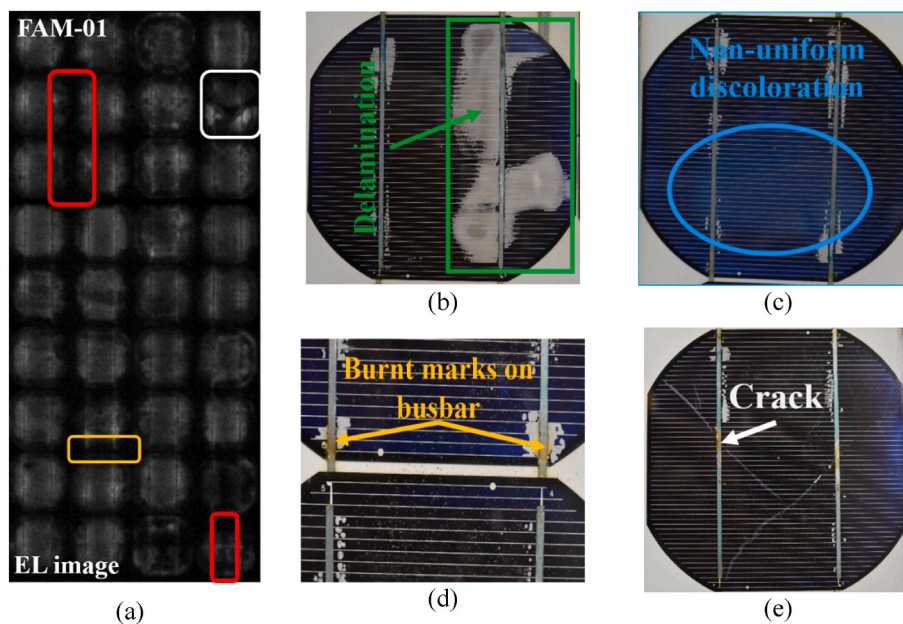
The six FAM exposed to outdoor field conditions for 20 years at two locations namely, Mumbai and Delhi in India have been investigated. Four of the FAM have been obtained from Mumbai and are henceforth named FAM-01, FAM-02, FAM-03, and FAM-04, and two PV module obtained from Delhi have been named FAM-05, and FAM-06. The multiple D&Ds observed in the FAM-01 during the visual inspection are shown in Fig. 2 (b), 2 (c), 2 (d), and 2 (e). Three dominant defects viz. non-uniform encapsulant discoloration, delamination, and metallization corrosion on the cells of the module have been observed. Correspondingly, a dominant signature of cell cracks (Fig. 2 (e)) can also be observed in the EL image (white enclosure) given in Fig. 2 (a). Metallization corrosion can be recognized as dark regions in the EL images encircled by the red box majorly around the cell edges. Furthermore, another type of defect observed in all the cells is burnt marks on the busbars as shown in Fig. 2 (d). The burnt marks on the interconnecting

ribbons of solar cells can also be traced in the EL image as dark spots at the edge of solar cells at multiple locations (encircled by a yellow box).

Fig. 2. (a) EL image of FAM-01 taken at I_{sc} of the module for a duration of 3 s, visual images showing (b) delamination, (c) non-uniform discoloration, (d) burnt marks on busbar, and (e) cracks in the cells of FAM-01.

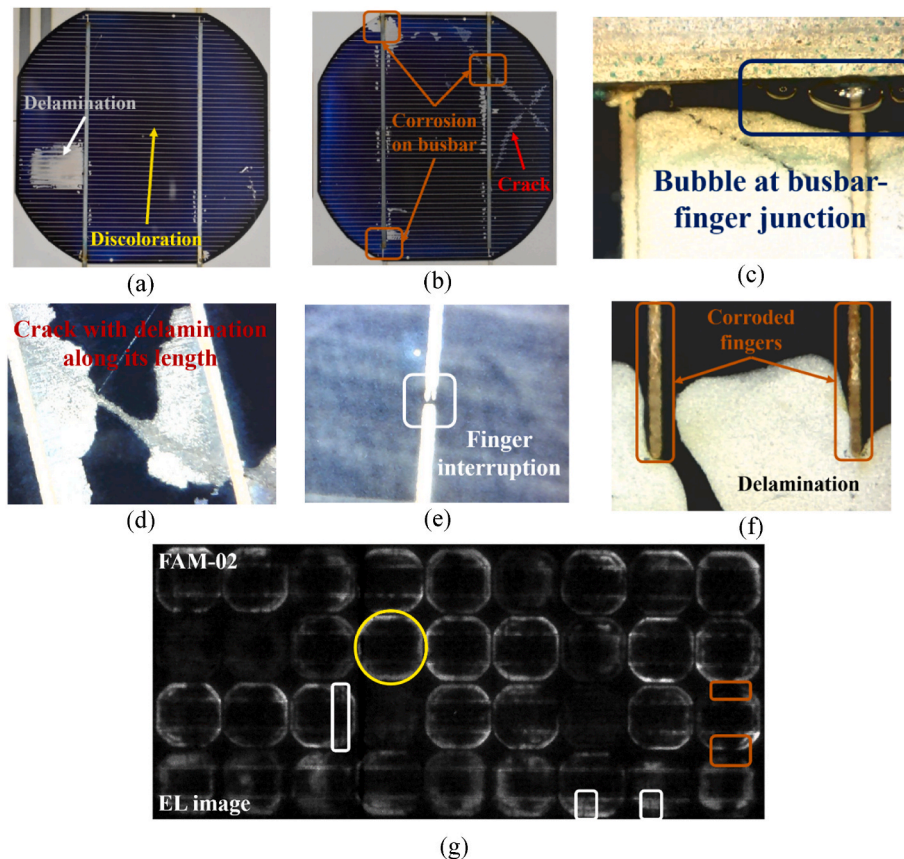
The visual inspection images, microscopic images, and EL image of the FAM-02 are shown in Fig. 4. Similar to FAM-01, encapsulant delamination, corrosion in the busbar and ribbon, cracks in the cell, and encapsulant discoloration have been identified from the visual inspection of the PV module as shown in Fig. 4 (a) and Fig. 4 (b). The corresponding microscopic images have also been taken for observing minor details, as shown in Fig. 4 (c), Fig. 4 (d), Fig. 4 (e), and Fig. 4 (f). Herein, finger interruption, as well as finger corrosion at the edges of solar cell and near busbar-finger interface have been observed. Whereas, green deposits on the interconnect ribbon, fingers corrosion accompanied with delamination, and cracks, similar to FAM-01 have also been observed. Also, trapped bubbles are found in the module as shown in Fig. 4 (c), which could be evidence of moisture ingress inside the module or poor lamination process during the encapsulation process. All these degradation modes can also be traced from the EL imaging of the FAM-02 as shown in Fig. 4 (g).

Fig. 4. Visual image showing (a) delamination & non-uniform discoloration, (b) corrosion on busbar and crack in a cell, microscopic image at $400\times$ zoom showing (c) bubble, (d) cracks, (e) finger interruption, (f) corrosion along delaminated region, and (g) EL image of FAM-02 taken at I_{sc} of the module for a duration of 3 s.

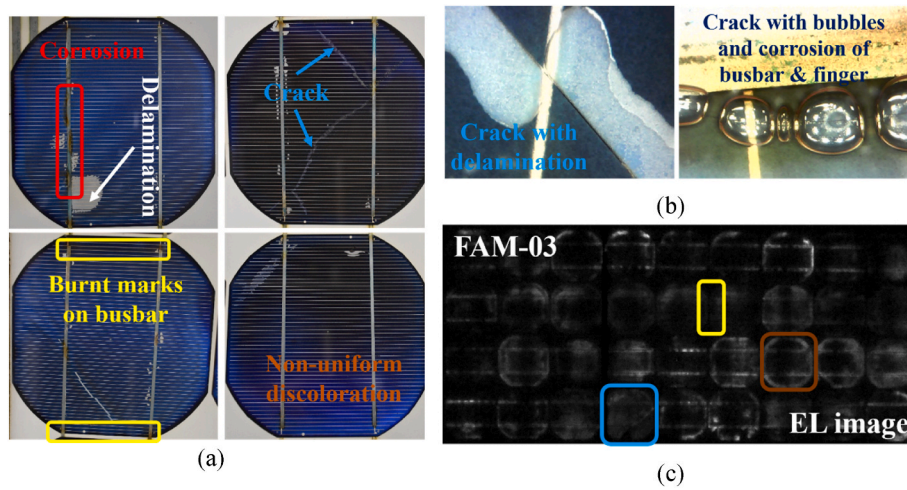
Likewise, the visual inspection images, microscopic images, and EL image of the FAM-03 can be observed from Fig. 5. The encapsulant delamination, corrosion in busbar with burnt marks, encapsulant discoloration in solar cells, and diagonal cell cracks are found in the visual images of PV module as can be shown in Fig. 5 (a). Through the microscopic images shown in Fig. 5 (b), defects such as finger breakages, impact cell crack, bubbles, finger and interconnect ribbon corrosion are found. The bubbles around crack region and corrosion sites are found in the FAM indicating at the possible presence of moisture inside the modules. The EL image of the FAM-03 is shown in Fig. 5 (c). The regions corresponding to D&Ds observed in the microscopic and visual inspection have been found to have dark appearance in the EL images (encircled in EL image with corresponding colored boxes). Furthermore, the degradation analysis of the FAM-04 has also been carried out and D&Ds similar to FAM-01, FAM-02, and FAM-03 have been found in this

Fig. 5. (a) Visual image, (b) microscopic image at 400× zoom, and (c) EL image of FAM-03 taken at I_{sc} of the module for a duration of 3 s.

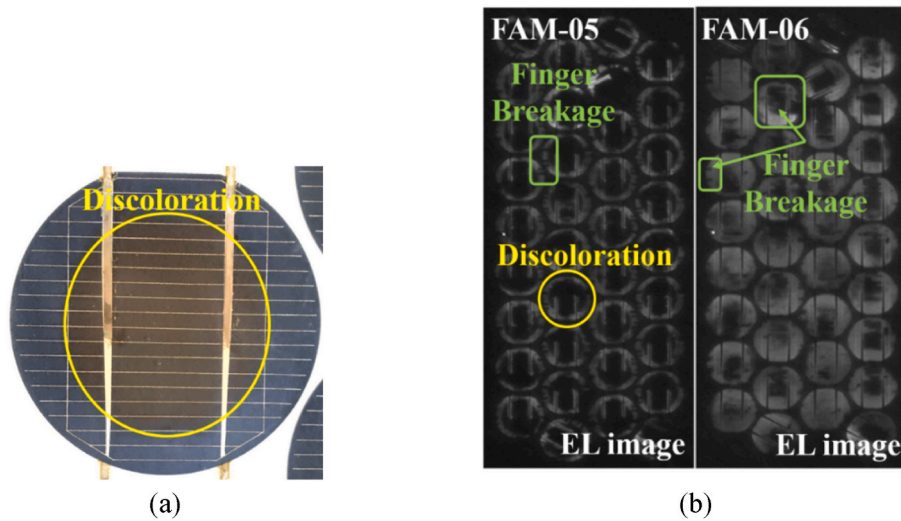
Further, FAM-05 and FAM-06 obtained from Delhi have also been analyzed. Visual inspection of modules showed encapsulant discoloration over the cells as a major degradation mode in FAM-05 as shown in Fig. 6 (a). It can also be observed in the corresponding EL image of FAM-05 as dark circular region (enclosed in yellow enclosure) at the centre of the solar cells as shown in Fig. 6 (b). However, the FAM-06 did not show discoloration during visual inspection. Instead, the EL image of FAM-06 showed the dark rectangular regions between the busbars and at the cell edges (enclosed in green enclosure) as shown in Fig. 6 (b). These types of pattern in EL images have been reported to occur due to finger breakages or interruption [11]. In addition, backsheets warpage also known as backsheet delamination or bubbling has been observed in both the modules.

Fig. 6. (a) Visual image of discoloration in FAM-05 and (b) EL image of FAM-05 and FAM-06 taken at I_{sc} of the module for a duration of 3 s.

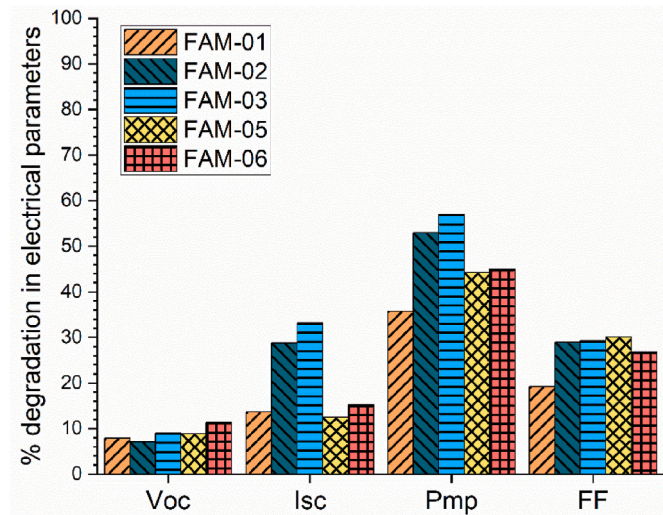
To investigate the overall impact of the above-mentioned D&Ds on the electrical parameters in the FAM, the I-V curve analysis has been performed. The percentage degradation in electrical parameters has been calculated with respect to the nameplate parameters for the FAM as shown in Fig. 7. Herein, the loss in FF has been identified as the dominant mode of power degradation. This was followed by the loss in I_{sc} and open-circuit voltage (V_{oc}). The loss in FF can be attributed to an increase in series resistance (R_s) due to finger and interconnect corrosion, observed as green and brown deposition in the microscopic images and cracks. The loss in I_{sc} can be attributed to the encapsulant discoloration, encapsulant delamination, and cracks [36].

Fig. 7. Degradation in electrical parameters for 20-year-old FAM calculated from I–V curve measurement performed at STC (AM 1.5 G, 25 °C, and 1000 W/m²).

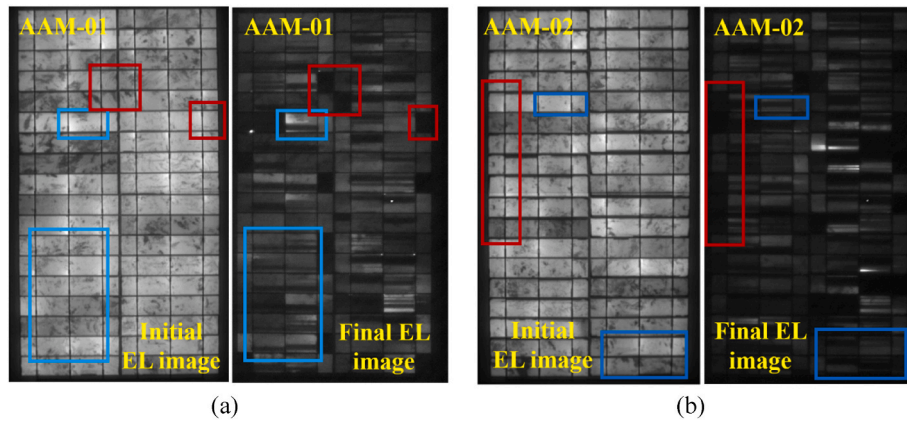
AAM-01, AAM-02, and AAM-03 were subjected to HF testing. Herein, modules have been exposed to cyclic temperature variation with high humidity conditions. The initial and final EL images of the AAM-01 and AAM-02 have been compared. The EL images of AAM-01 as shown in Fig. 8 (a), shows multiple breakages of the fingers between inter-connect ribbons, visible as dark elongated rectangular regions (enclosed in the blue box). To substantiate this fact, microscopic images of these sites have been taken and broken fingers have been detected as shown in Fig. 9 (a). Likewise, the initial and final EL image of the AAM-02 is shown in Fig. 8 (b). In the final EL image of the AAM-02, blue boxes indicate multiple finger breakages similar to AAM-01. On the other hand, the red box in the final image of AAM-01 and AAM-02 indicates the complete separation of the cell from the busbars at the edges of the cell. These can be attributed to the cyclic variation of the temperature in the HF test that induces thermo-mechanical fatigue at the busbar-finger interface which causes finger breakage [20,37].

Fig. 8. The initial and final EL images of (a) AAM-01 and (b) AAM-02 subjected to 50 cycles of HF test taken at I_{sc} of the module for a duration of 3 s.

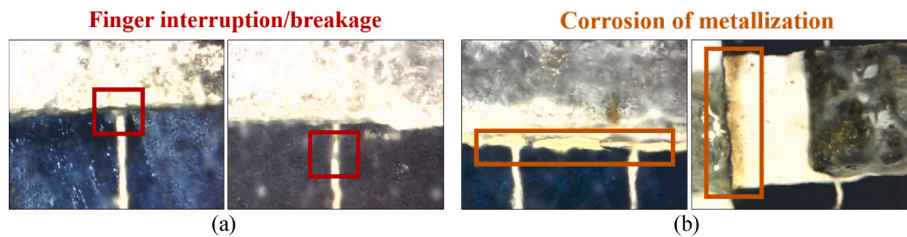
Fig. 9. Microscopic images of (a) finger interruption/breakage and (b) metallization corrosion in the AAM subjected to HF test at 400× zoom.

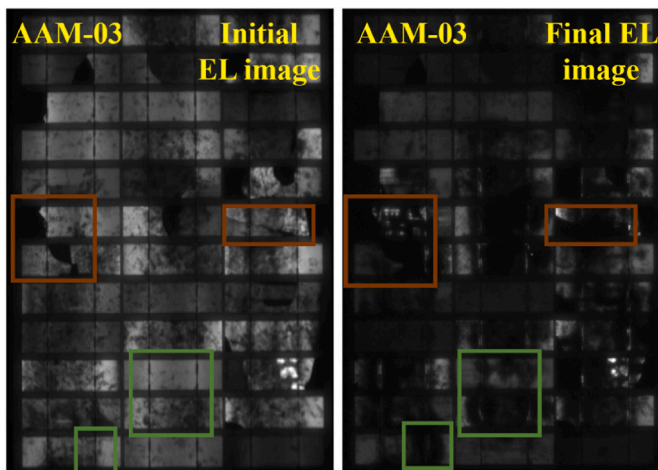
In addition to the multiple finger breakages as seen in the AAM-01 and AAM-02, the module named AAM-03 also showed propagation of existing cracks. The initial and final EL images of the AAM-03 are shown in Fig. 10. The brown box in the initial EL image shows the presence of crack that propagated into the severe crack in the final EL image causing the detachment of the active cell area from the busbar. The increase in the dark region around pre-existing crack regions in the final EL images indicate at the possibility of moisture ingress through cracked region. Additionally, dark patches were found around the busbars as shown in the green box of the final EL image of the AAM-03; however, there was no prior crack at this site. This indicates the presence of corrosion of metallization due to moisture ingress as observed through microscopic inspection shown in Fig. 9 (b). It must be noted that non-homogeneous dark patches are present in the final EL images at pre-existing defects sites which shows the non-homogeneous propagation

Fig. 10. Initial and final EL images of the AAM-03 subjected to 50 cycle of HF test taken at I_{sc} of the module for a duration of 3 s.

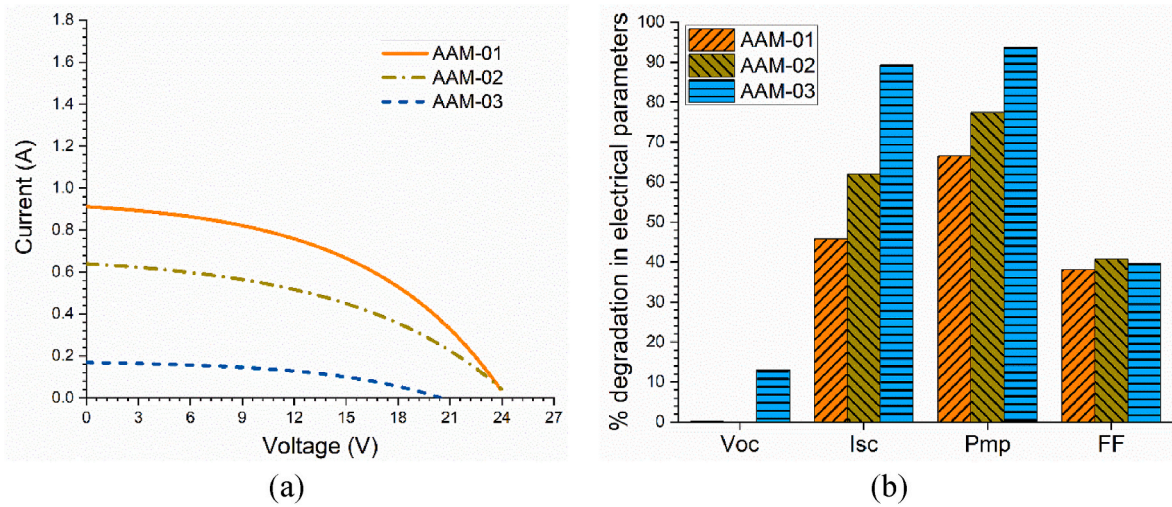
Correspondingly, to investigate the electrical impact of the observed D&Ds, I-V curve analysis has been performed. The I-V curves and change in electrical parameters of AAM subjected to HF test is shown in Fig. 11 (a) and Fig. 11 (b), respectively. Herein, loss in I_{sc} was observed as the dominant mode of power degradation. Whereas, loss in FF has been low in comparison, which is contrary to the perception that finger breakages only lead to an increase in R_s , causing a loss in FF. In the HF test, the presence of high moisture content has led to corrosion of metallization causing hindrance in the current collection and additional loss in I_{sc} [38]. Moreover, the finger breakages observed under this test were multiple and in the cluster, leading to large electrically disconnected regions causing a loss in the active area of the cell for current production, thus, causing a loss in I_{sc} .

Fig. 11. (a) Current-voltage plot at standard test conditions (AM 1.5 G, 25 °C, and 1000 W/m²) and (b) degradation in electrical parameters of AAM subjected to 50 cycle of HF test.

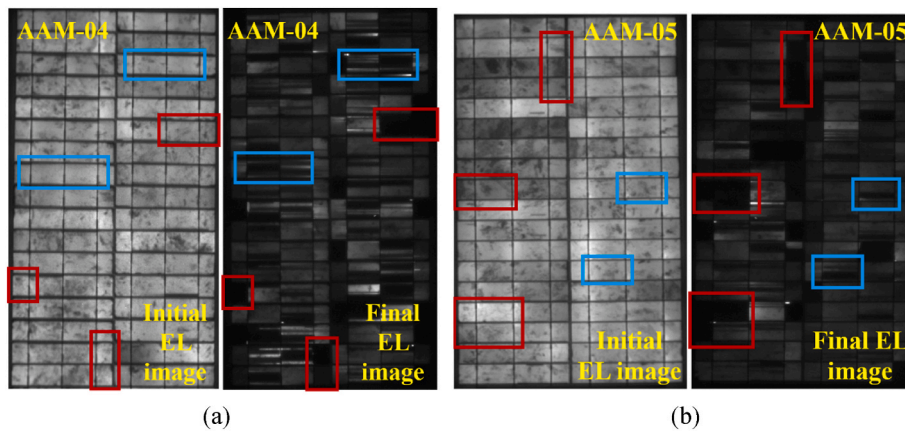
The modules named AAM-04, AAM-05, and AAM-06 were subjected to TC test. The initial and final EL images of the AAM-04 and AAM-05 are compared as shown in Fig. 12. The multiple finger breakages have been found in the final EL image of the AAM-04 as shown in the blue box of Fig. 12 (a). A similar defect is also found in the final EL image of the AAM-05 as shown in Fig. 12 (b). In addition, at some locations all fingers between the interconnect ribbons have also been found to be broken in both AAM-04 and AAM-05, indicated as red-colored boxes in the final EL images. To validate these defects, microscopic images of these sites have

Fig. 12. The initial and final EL images of (a) AAM-04 and (b) AAM-05 subjected to 200 cycle of TC test taken at I_{sc} of the modules for a duration of 3 s.

also been taken and broken fingers have been detected.

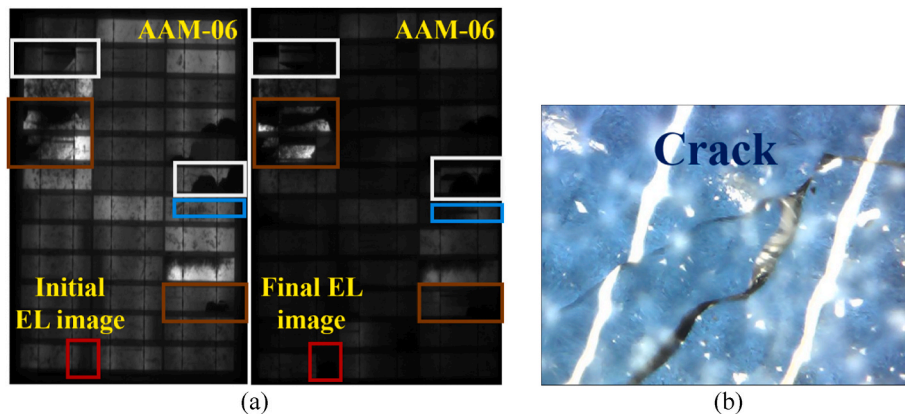
The initial and final images of the AAM-06 are shown in Fig. 13 (a). It can be seen from the brown boxes that the area of sharp dark regions characteristic to the presence of cracks and cracks in the initial EL image has increased in size in the final EL image indicating at the propagation of pre-existing cracks. The microscopic image of cell crack is

shown in Fig. 13 (b). The red and blue boxes in EL images indicate fingers breakage at the busbar-finger interface which is similar to the degradation observed in HF test. However, in comparison to HF test, it should be noted that non-homogenous dark regions are not present in the vicinity of pre-existing cracks. Non-homogenous region in HF corresponded to humidity related degradation. Their absence in TC could

Fig. 13. (a) Initial and final EL images taken at I_{sc} of the module for a duration of 3 s and (b) microscopic image of crack at 400× zoom of the AAM-06 subjected to 200 cycles of TC test.

be due to dry conditions under TC test. However, characteristic patterns similar to finger breakages are visible around pre-existing cracks (enclosed in white box) in final EL image.

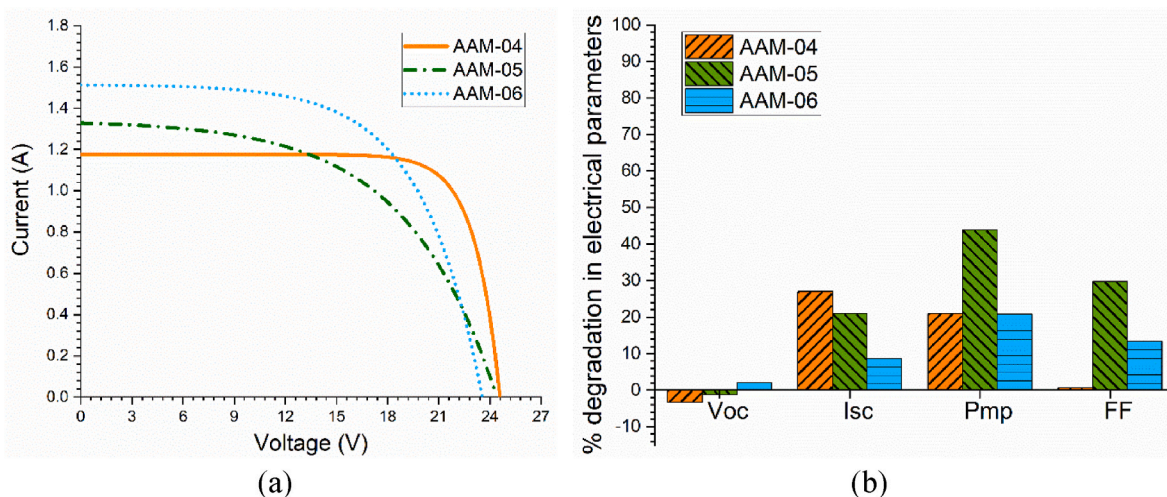
Fig. 14. (a) Current-voltage plot at standard test conditions (AM 1.5 G, 25 °C, and 1000 W/m²) and (b) degradation in electrical parameters of AAM subjected to 200 cycles of TC test.

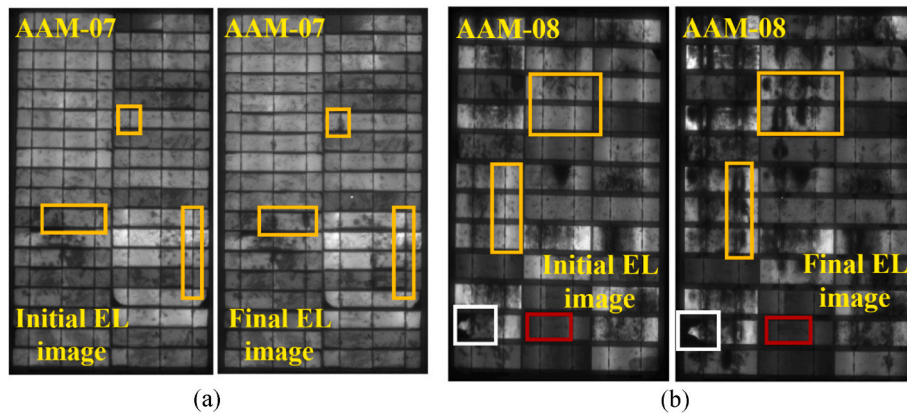
Like the HF and TC test, two unaged PV modules named AAM-07 and AAM-08 have been subjected to the DH test. The initial and final EL images of the AAM-07 and AAM-08 are shown in Fig. 15 (a) and 15 (b), respectively. The non-homogenous dark patches are found around the busbars as shown in the yellow boxes of the final EL images of the AAM-07 and AAM-08. However, the visual inspection did not reveal the presence of metallization corrosion. This type of patch around busbars without visible signature under moisture conditions can be attributed to the migration of tin from the solder material which can lead to metallization corrosion and increased R_s [39–41]. The DH test consists of high temperature and humid conditions that promote moisture ingress into the vicinity of the interconnect ribbon. In addition, some finger breakages have also been found between the interconnect ribbons and these can be seen from the red boxes in the final EL image of the AAM-08.

The propagation of pre-existing cracks has not been detected in the modules, and an example of this is shown in the EL image of AAM-08 (white box). This may be due to the absence of cyclic temperature variation in the DH test. In addition, backsheets warpages or backsheets delamination were observed in the DH test subjected AAM. The comparative analysis of D&Ds observed in DH subjected AAM with FAM shows moisture-ingression induced degradation as common degradation

Fig. 15. The initial and final EL images of (a) AAM-07 and (b) AAM-08 taken at I_{sc} of the module for a duration of 3 s of the AAM subjected to 3000 h of DH test.

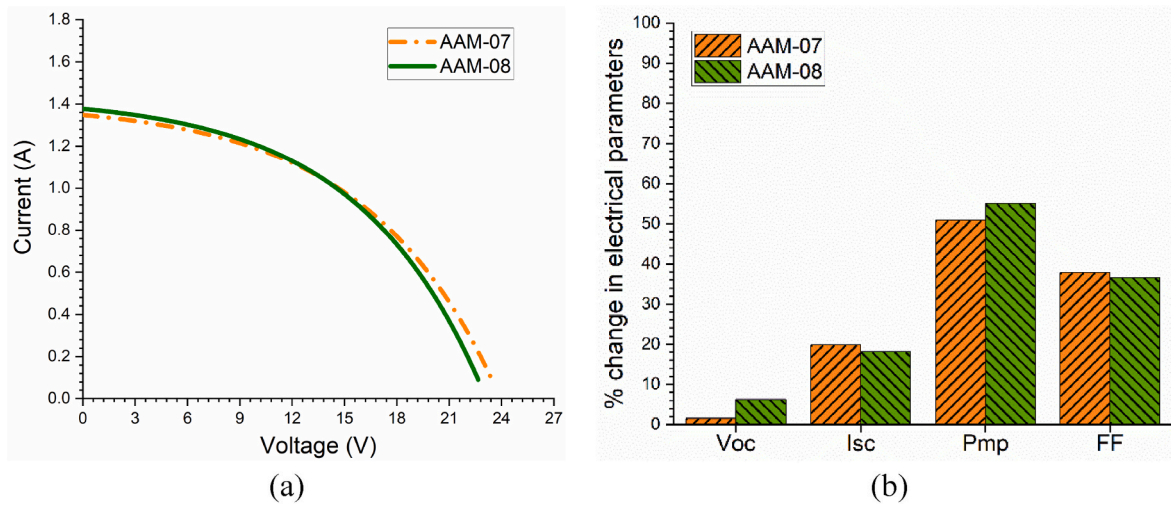
The electrical impact of the D&Ds observed in the DH test has been investigated using I-V curve analysis. The plot showing, I-V curves and percentage degradation in the electrical parameters for AAM subjected to DH test is given in Fig. 16 (a) and Fig. 16 (b), respectively. It can be observed that the loss in FF is the main factor responsible for power degradation. The high losses in FF can be attributed to the increase in R_s caused due to the interconnect corrosion and migration of tin at the busbar-finger interface. Comparatively, the loss in I_{sc} is low, primarily due to the localized effect of tin migration-related degradation over the module.

Fig. 16. (a) Current-voltage plot at standard test conditions (AM 1.5 G, 25 °C, and 1000 W/m²) and (b) degradation in the electrical parameters of AAM subjected to 3000 h of DH test.
