Corrosion of candidate materials for use in alkaline water electrolysis

M. Tjelta and Jon Kvarekvål
Institute for Energy Technology
P.O. Box 40, N-2027 Kjeller
Norway

Key words: Alkaline, water electrolysis, CRA, corrosion

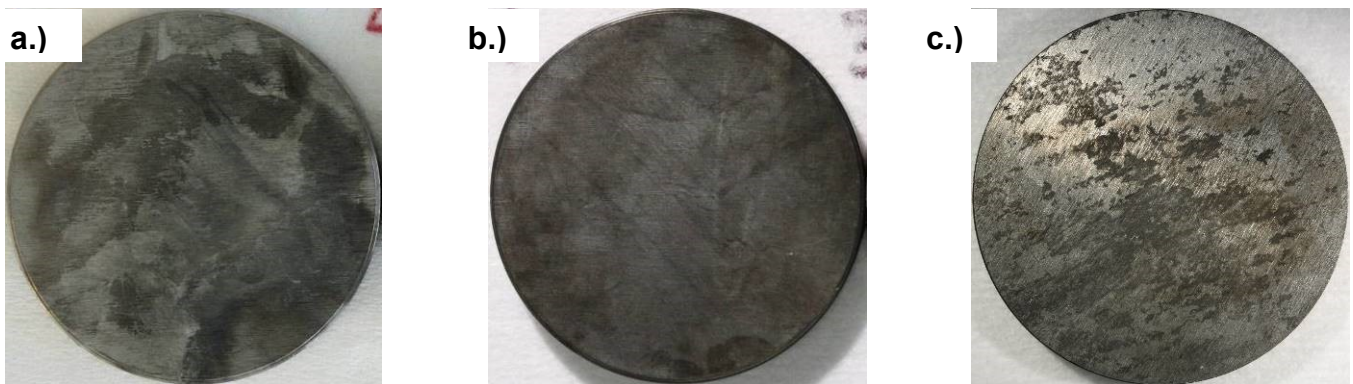
Figure 3: Pictures of carbon steel coupons after exposure at (a) 25 °C, (b) 60 °C and (c) 80°C after stripping in HCl

Figure 2 a, b and c show pictures of carbon steel corrosion coupons, with all corrosion products still intact, from the experiments at 25, 60 and 80 °C. In Figure 3, pictures of the same coupons are shown after treatment in inhibited HCl and Figure 4 shows false color surface profiles of the stripped surfaces. The color representation in a paper may, for various technical reasons, not represent the actual color of the specimen. Therefore, the observe color of the various corrosion coupons are summarized in Table 5 to be used as a guide to the pictures in Figure 2, Figure 5 and Figure 8.
